HYDROCENSUS OF THE RUTONGO MINE CONCESSION AREA

TRINITY METALS

DRAFT

GT1377

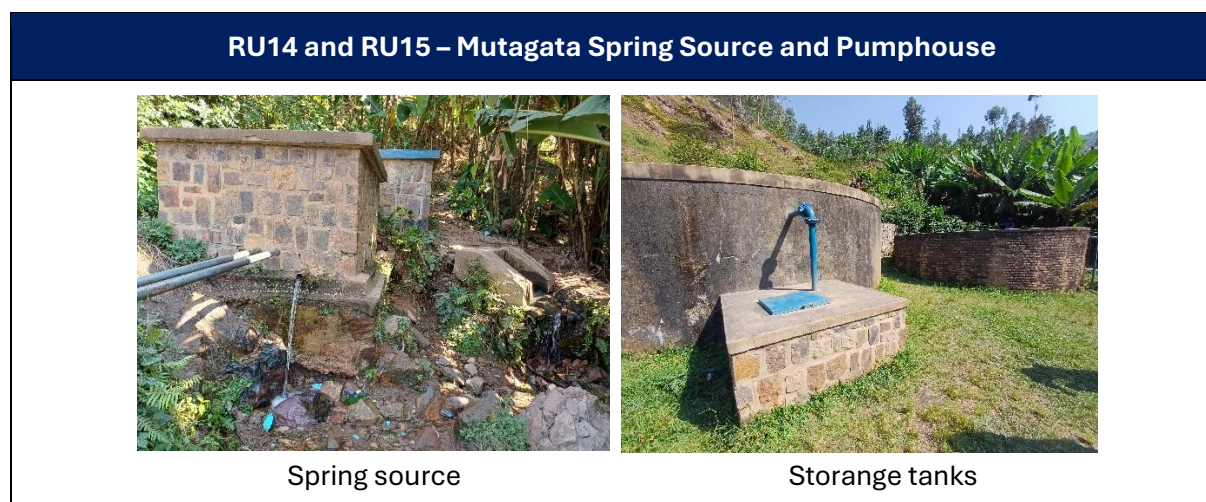
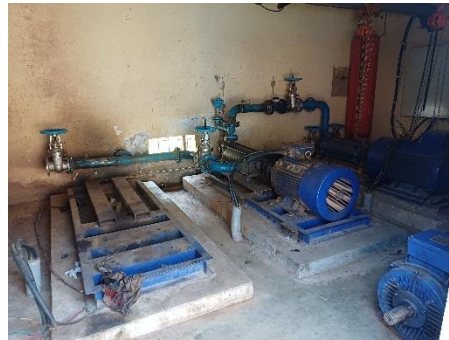
RU14 and RU15 – Mutagata Spring Source and Pumphouse

During the field assessment, the team engaged with Mr. Theoneste Karihije, the operator responsible for the pumphouse. The facility is equipped with two pumps; each rated at 23 m³ per hour under normal operating conditions. In theory, and with both pumps functional and operated in alternation, the system could sustain continuous pumping (24 hours per day), providing a reliable flow to storage and onward to the distribution network. However, this system is limited by technical failures. At the time of the study, only one pump was operational, with the second pump having been out of service for approximately two years. This has effectively halved the pumping capacity and also potentially increased the operational risk, as the entire supply now depends on a single pump. To avoid overheating and mechanical strain, the remaining pump is operated in two shifts: 3:00–9:00 a.m. and 4:00–10:00 p.m. This schedule allows the pump to cool during the day. This results in intermittent supply at most, or no supply at some villages at the three sectors.

To address these challenges, two interventions are recommended:

- Restoration of the pump unit: Repairing or replacing the non-functional pump would restore full design capacity, enable alternating operations, and reduce the risk of total supply failure.
- Expansion of storage capacity: Constructing additional reservoirs or upgrading existing tanks would allow greater volumes to be stored during low-demand hours, ensuring that adequate reserves are available during peak use periods and the dry season.

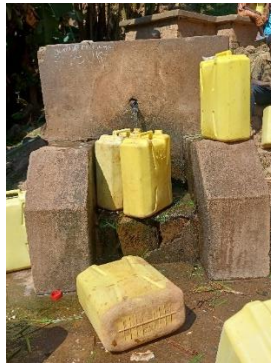
RU16 - Ruri Village Water Collection Point

Despite the reliability of this collection point, maintenance issues or pump failure at the spring or pumphouse, could significantly impact water availability for multiple villages, highlighting the need to fix the issues at the source.

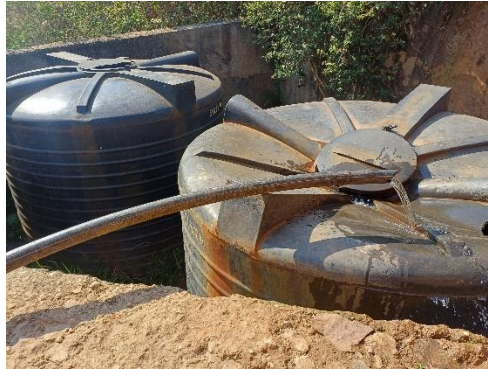
RU13 – Pumphouse for Rutongo Mine Headquarters

Storage tanks at the mine pumphouse

Water is pumped from the Mutagata spring source to the storage tanks at this point. This water is then pumped from the storage to the Trinity Rutongo Mine headquarters and Nyamyumba mine.

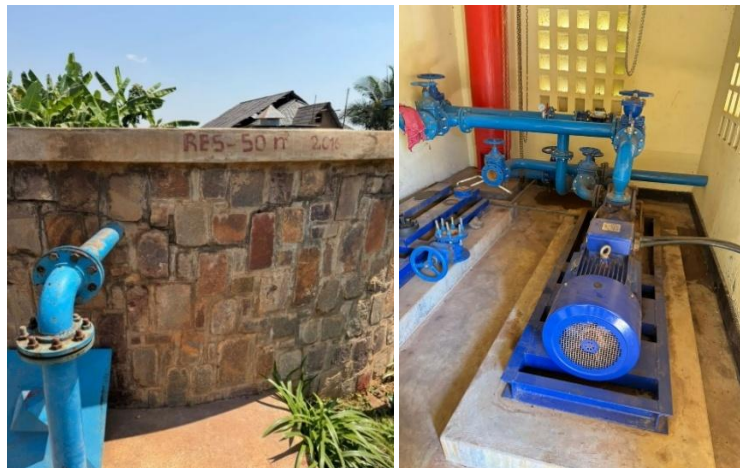
RU05 – Distribution Tanks and Pumphouse at Nyarurembo Village

Water from the Mutagata spring source at Ruri village is pumped to these distribution tanks located in Nyarurembo village. The system comprises two tanks, a 50 m³ tank and a 100 m³ tank, with the larger 100 m³ tank observed to be empty at the time of the study, likely due to operational issues with the pump at the Ruri village source and perhaps also reduced yield due to the dry season. These tanks form a critical component of the local water supply network, serving approximately 40 water collection points through a combination of direct pumping to Bubangu and Mvuzo cells, and gravity-fed distribution to the remaining villages in the area.

In addition to village collection points, the tanks provide water to the Murambi Health Centre, located a few metres from the distribution site, and to nearby schools such as Groupe Scolaire APAPEC Murambi. It was noted that Groupe Scolaire APAPEC Murambi maintains multiple tanks for rainwater harvesting, which are likely used to supplement water supply during periods of reduced water availability from the main distribution network.

Observation at the site highlighted the importance of functional pumping infrastructure at the source, as disruptions directly impact the storage and distribution capacity, affecting both residential and institutional water access across the network and that these issues may become more pronounced during the dry season.

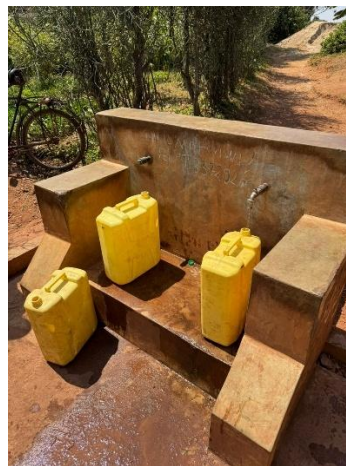
RU04 – Nyarurembo Water Collection Point

Although staff at the distribution point indicated that seasonality is not a limiting factor, it is possible that their perception is influenced by their constant presence at the main distribution tank where water is consistently available, which may not necessarily reflect availability at the villages. Observations also indicated that one of the pumps at the source pump station has been out of service, suggesting that the combination of the non-operational pump and seasonal fluctuations may further reduce water supply at the village level.

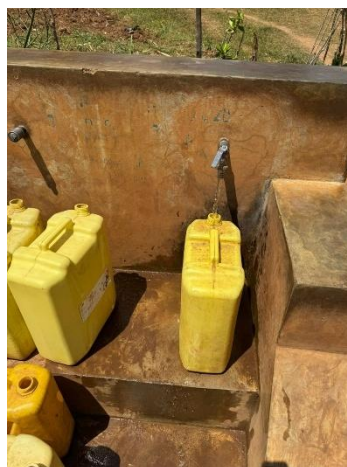
RU06 – Nyarurembo Water Collection Point

While this collection point is generally reliable, its capacity and supply depend on the functionality of the main distribution system. Although this point remains reliable, during periods of high demand or when both pumps at the source go out of service, community members may experience limited or no access to water, potentially necessitating travel to farther alternative points or springs and increasing the burden on households.

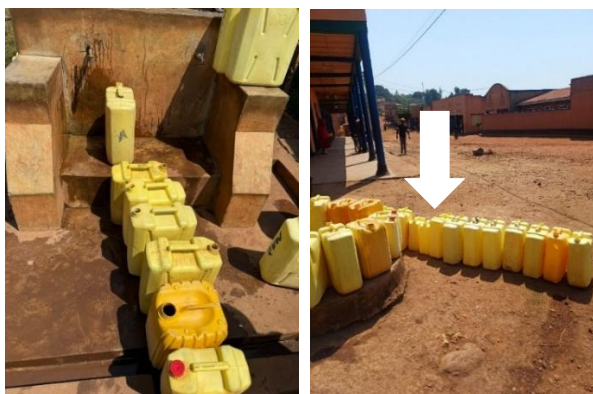
RU03 – Buliza Village Water Collection Point

The water collection point located next to the Mugambazi Cell Office in Buliza Village was functional at the time of assessment, with several community members observed collecting water. This site serves as an alternative supply point for residents from surrounding villages, including Amataba and Ruri, when water is unavailable at their primary collection points, as indicated by the large number of jerry cans at this point present during the study.

A concern about this point is that despite its reliability, there is an overreliance on this single collection point for Buliza, Ruri, and Amataba villages. Given the sizes of these communities, there is a need for additional reliable water sources closer to the communities.

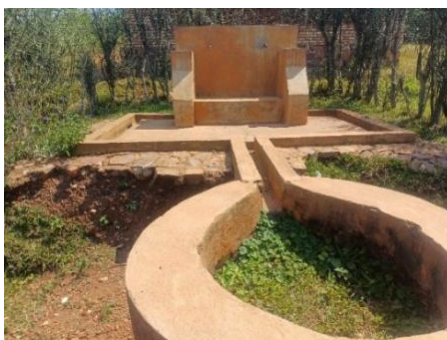
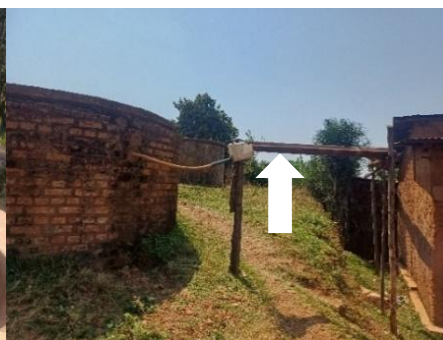
RU02 – Amataba Village Water Collection Point

Water distribution point

Rainwater harvesting

The water collection point supplying Amataba was found to be non-functional at the time of assessment, with no water available. Surrounding the site, small subsistence plots cultivated with cassava and sweet potato were observed, reliant on rainfall for irrigation.

A concern associated with this collection point is the lack of reliable supply from the source, with rainwater harvesting serving only as a minimal and unsustainable alternative. The alternative water source for the community members is a water collection point at Buliza village (RU03), at approximately 1.5 km from this point.

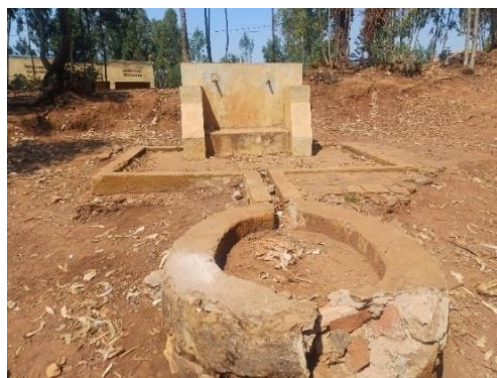
RU01 – Ruri Villages Water Collection Point

The water collection point at Kabuga Centre in Ruri Village was found to be non-functional at the time of assessment, with no water available. This point is supplied by the distribution tank at Nyarurembo village and the pump and capacity issues at the source has had knock-on impacts affecting the distribution tank and water collection points especially farther from the distribution tank including the point at Amatoba (RU02) approximately 1km from this point.

A key concern associated with this supply system is the inadequate pumping capacity, which limits the reliability of water delivery across the network and places an additional burden on households and small business owners who have to incur an additional cost of hiring individuals with motorcycles/bicycles to get them water.

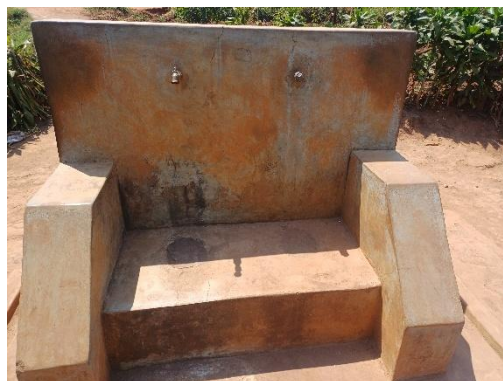
RU33 –Kabuga Village Water Collection Point

The water collection point in Kabuga Village, located approximately 600 m from the Ruri village point (RU01), was observed to be non-functional at the time of the study. Community reports indicate that this point has been without water for approximately two months, forcing households to rely on alternative and often distant sources, which can increase the time and effort required for daily water collection. This point is connected to the same supply network as the Ruri and Amatoba points, all of which are fed by the distribution tanks located at Nyarurembo Village. Field observations suggest that at the time of the study, the water supply effectively terminated at Buliza Village, leaving the three downstream points (Amatoba, Ruri, and Kabuga) without reliable access. This interruption in service highlights a critical vulnerability in the distribution network, with direct implications for community water security and, household burdens especially for the Kabuga, Amatoba and Ruri villages.

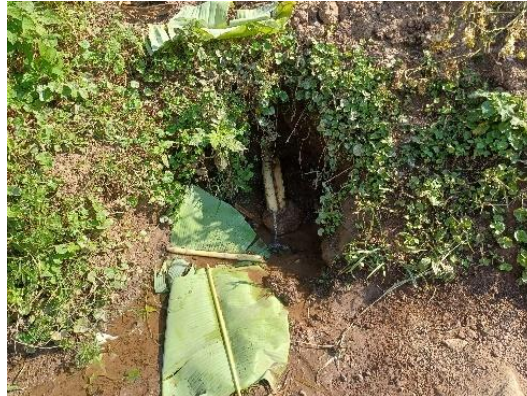
RU25 –Kabeza Village Spring

The spring is located in Kabeza Village, across the valley from the Trinity Rutongo Masoro Mine. The spring water is actively used by community members for small-scale irrigation, with shallow trenches directing the flow to nearby crop fields. Banana and sweet potato are cultivated in the fields. Kabeza village is located across the road from Buliza and Iraro villages, it also neighbours Amataba village. It is likely that households in Kabeza village closer to the water collection points at Amataba and Ruri villages utilise these points when they are functional.

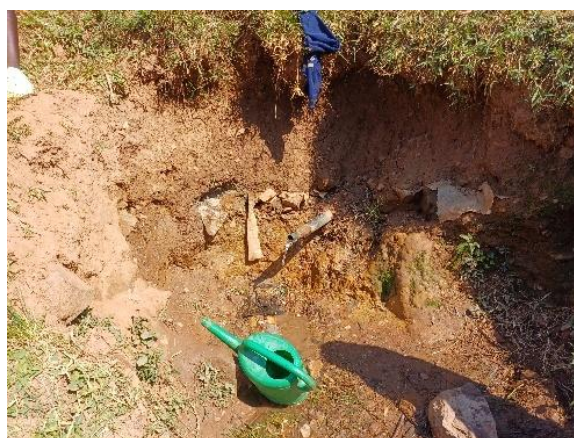
RU26 –Kabeza Village Spring

The combination of low flow and the physically demanding collection process increases vulnerability of this community to water shortages, particularly during periods of peak demand or extended dry seasons.

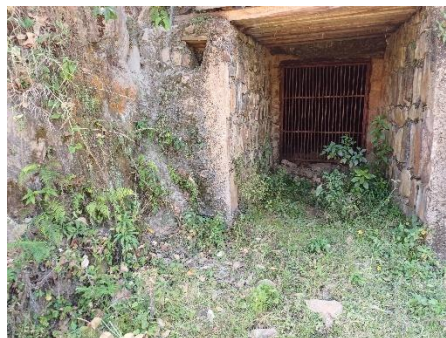
RU29 –Tunnel 7 Spring

Locked entrance to Tunnel 7

Kigomwa. Mine personnel did also report that Kigomwa village does receive water via a tank located at Kabuga village (RU34)

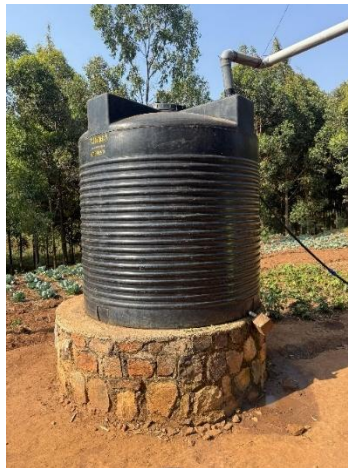
RU34 –Kabuga Village Tanks Supplying Kigomwa Village

The tanks are located adjacent to the Masoro Learning and Sports Centre at Kabuga village and supply water to Kigomwa Village. Water is distributed twice daily in three-hour shifts, with each 20-litre container filled at a cost of 100 Rwandan Francs. While this arrangement provides some relief to the Kigomwa community, it also highlights their continued vulnerability, as the village’s designated water collection point has been non-functional for an extended period. Reliance on paid, time-restricted access reflects the same concerns raised at nearby collection points—namely limited availability, financial strain on households, and the absence of a reliable, sustainable water supply system. At the time of the study, no operator was present, and details on the water source and operational specifics could not be confirmed. The information provided for this water source was obtained from local mine personnel.

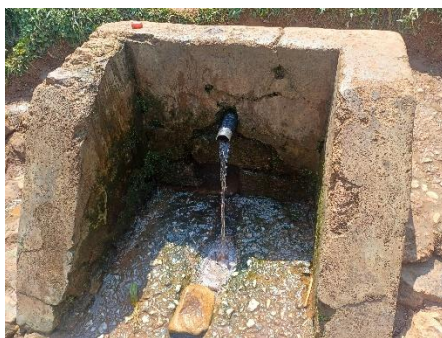
RU30 –Rusenyi Village Spring

The spring is located in Rusenyi Village, approximately 145m from the Gatiti River, and serves as a key source of potable water for both Rusenyi and Kigomwa villages. However, community members reported that the water often becomes turbid during the rainy season, raising concerns about its quality and reliability especially with the two villages depending on this source. In addition, mine personnel indicated that the spring is located adjacent to a historical mine waste dump, which could pose potential risks of contamination, particularly during periods of high rainfall when runoff and leaching are more likely. These factors highlight the vulnerability of the spring and the dependence of local communities on a potentially at-risk water source. SLR lab tested water from this spring in 2023 and found that it was within the 2022 WHO Guidelines for Drinking Water (WHO, 2022).

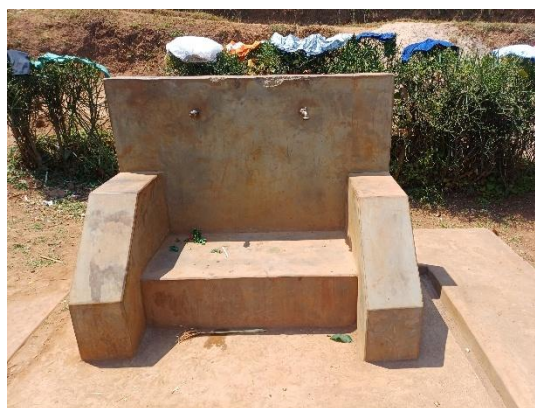
RU31 –Rusenyi Village Water Collection Point

The water collection point in Rusenyi village, located approximately 2.5 km uphill from the Rusenyi spring (RU30), has reportedly been without water for the past three years. Community members suggested that the source of this collection point may be at Marengé (location not confirmed during this study) and indicated that a malfunctioning pump is likely the cause of the interruption, though they were not certain of this. As a result, residents are forced to rely on alternative sources, such as the Nyamateke spring (location not confirmed during this study) or the Rusenyi spring (RU30) down the hill. However, and as stated, the Rusenyi spring itself is associated with concerns, as it becomes turbid during the rainy season and is situated adjacent to a historical mine waste dump. This raises water quality and quantity concerns for both Rusenyi and Kigomwa villages, which depend on this spring for potable water.

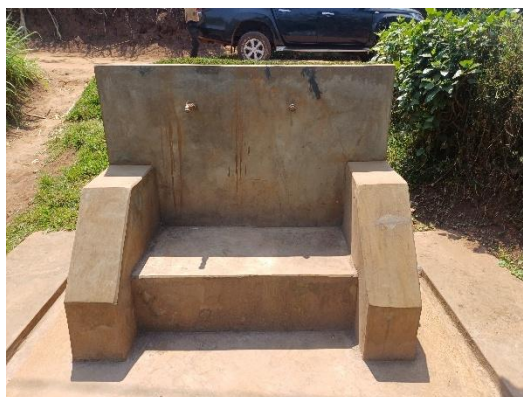
RU32 –Marengo Village Water Collection Point

The water collection point in Marengo Village is located approximately 380m from the Rusenyi Village collection point (RU30). Similar to RU30, this point has also been without water, for approximately three years, due to the same underlying issues as with RU30. The close proximity of the two collection points suggests that both may be supplied from the same source or pumping system, indicating a broader system failure rather than an isolated problem.

The situation at Marengo reinforces the concerns raised at Rusenyi (RU30): prolonged non-functionality of water points, likely linked to pumping and infrastructure failures, has forced communities to rely on distant and uncertain spring sources. Therefore, communities at

Rusenyi, Marengo and even Kigomwa face persistent vulnerability in terms of access to safe and reliable water.

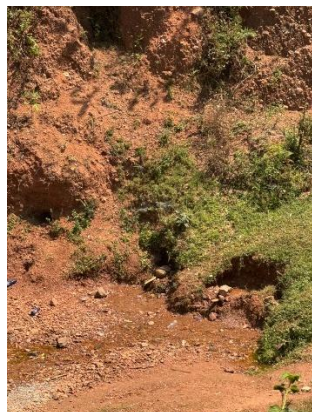
RU24 –Nyarurembo Village Spring

The spring is located in Nyarurembo Village within the Trinity Rutongo Gasambya Mine along the Kivomo River. No community members were observed collecting water from this point, which may suggest that it is not commonly used for domestic purposes. Its location within an active mining area places the spring at high risk of potential contamination from mining activities. This makes the source unsuitable for safe domestic use unless d. The nearest villages to this source are Rubaya and Kanunga.

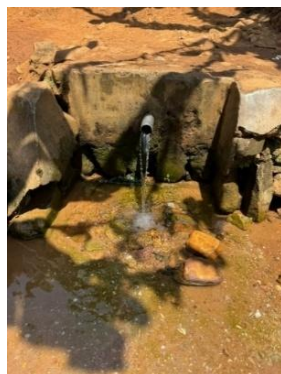
RU18 – Nyabinyana Village Spring

| RU18 – Nyabinyana Village Spring | | | |
|---|---|---|---|
| <p>The spring located in Nyabinyana Village is situated approximately 45 m from the Mutagata River and downstream of Nyamyumba Mine. It provides a perennial source of water for the village. It also functions as an alternative water source for Mutagata and parts of Nyarurembo villages. The spring is utilised for domestic purposes and for irrigating crops. Agricultural activity was observed in the surrounding area, with shallow trenches constructed to channel water from the spring to the cultivated fields.</p> | | | |

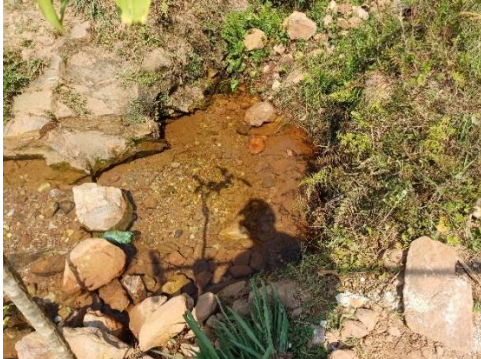
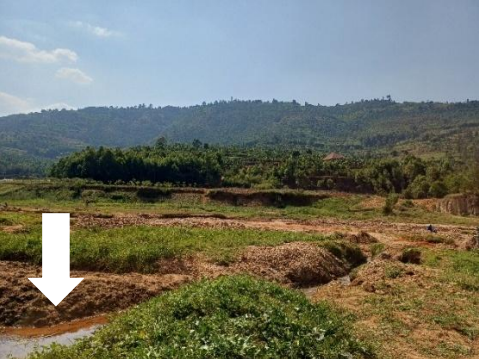
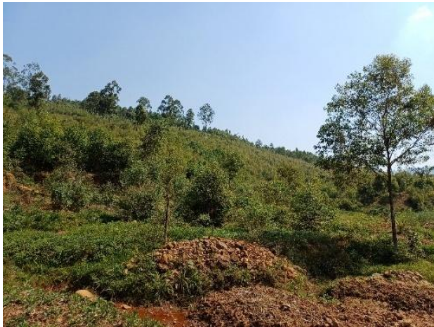
| RU20 –Nyabinyana Village Spring | | | |

| RU20 –Nyabinyana Village Spring | | | |
|---|---|--|---|
| <p>Spring source</p> | | <p>Shallow trenches dug to water crops</p> | |
| <p>Gum trees planted on the surrounding hills</p> | | | |

Gum trees have been planted on the surrounding hills, which may affect the spring’s flow by increasing water uptake from the soil and potentially reducing recharge to the aquifer feeding the spring. Careful management of the surrounding land, including vegetation impacts, is recommended to maintain the reliability and sustainability of the spring.

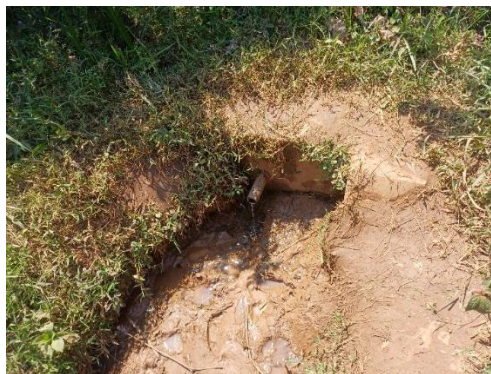
RU21 –Musega Village Spring

The decline in yield may be linked to changes in groundwater recharge, land use pressures, or catchment conditions. This highlights the need for appropriate catchment management and serves as an indication of existing potential threats to other spring sources in the area as well.

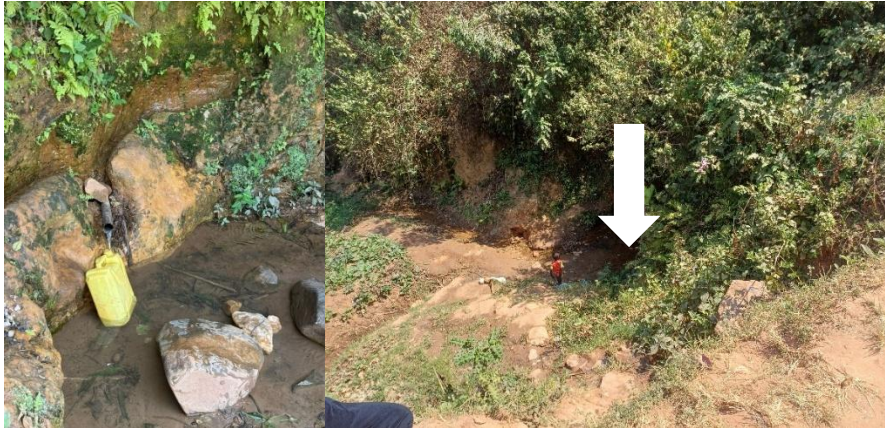
RU22 – Musega Village Spring

Spring source

Location of the spring at the bottom

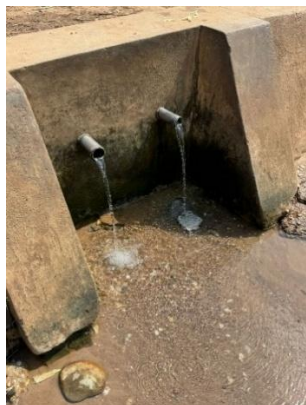
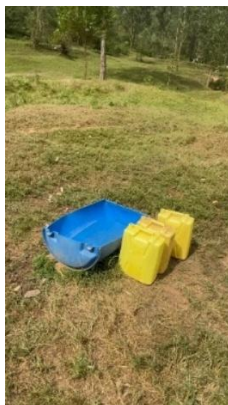
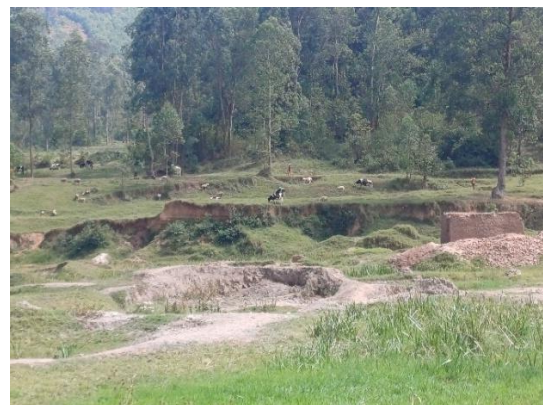
RU19 – Rusine and Nyabinyana Villages Spring

Spring source

Livestock watering

Cattle at the far bank of the Rusine River

| RU19 – Rusine and Nyabinyana Villages Spring | | | |
|--|---|---|---|
| <p>The spring located in Rusine Village is situated approximately 105 m from the Rusine River and 1.4 km upstream of the confluence with the Nyabugogo River. This spring provides a perennial source of water. It supplies both Rusine Village and parts of Nyabinyana Village. In addition to domestic use, the spring water is utilised for livestock watering. Livestock were observed grazing in the vicinity of the spring, indicating that the source plays a critical role in supporting both household and agricultural needs for the surrounding villages.</p> | | | |

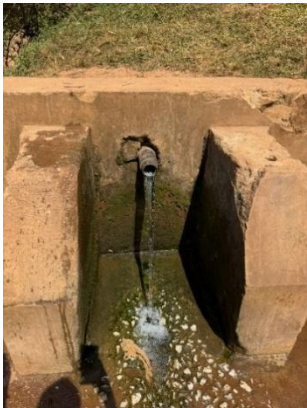
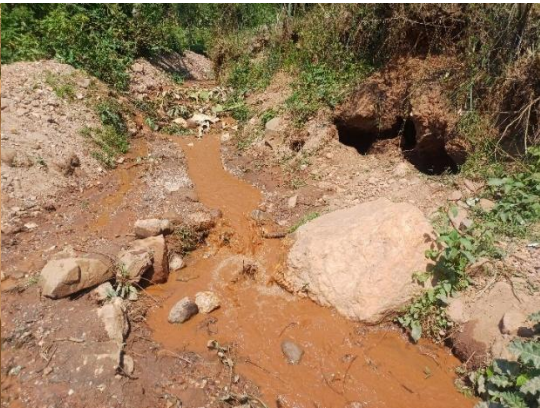
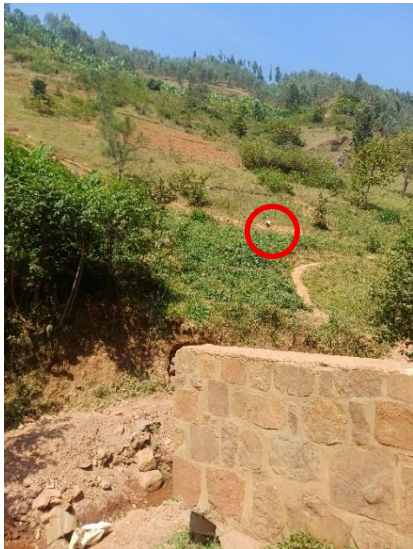
| RU08 – Iraro Village Spring | | | |

| RU08 – Iraro Village Spring | | | |
|--|---|---|---|
| Spring source | | Turbid water in the Rusine River tributary | |
| Child (in red circle) walking down the hill to the spring to collect water | | | |

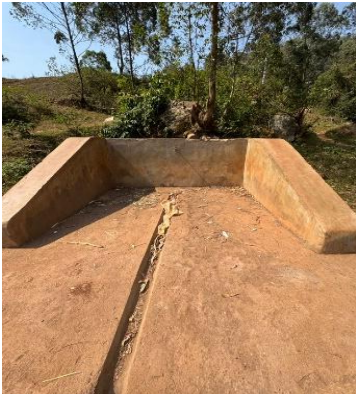
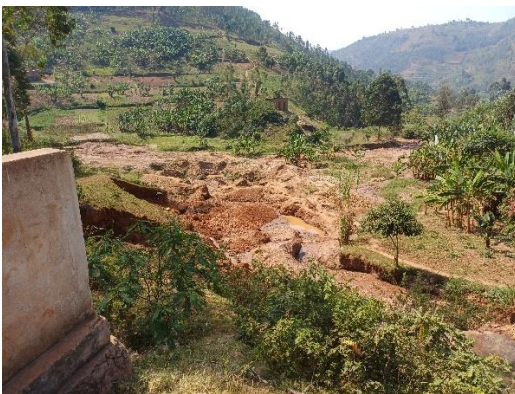
| RU09 – Iraro Village Spring Extension Water Collection Point | | | |

| RU09 – Iraro Village Spring Extension Water Collection Point | | | |
|--|---|--|---|
| Water collection point | | Illegal mining in the Rusine River | |

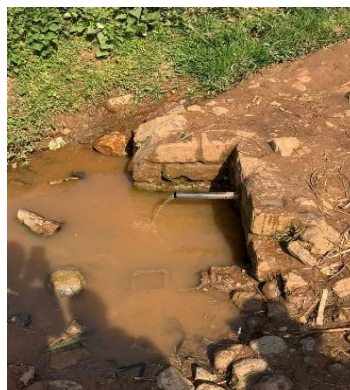
RU10 – Nyakibande Village Spring

The spring is located along the Nyakibande River and serves as a water source for Nyakibande village and as an alternative water source for Gisiza village. The spring is also likely utilised by surrounding communities, including Karambi, Kigarama, and Nyakizu. Community members reported that the spring becomes inundated during the rainy season and noted the presence of another alternative spring approximately 250 m from this site (RU11).

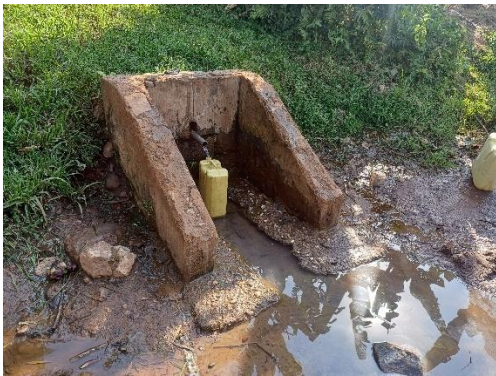
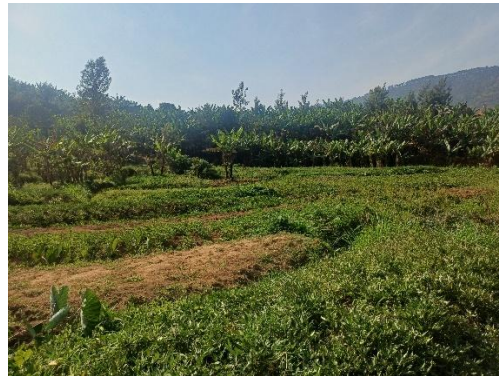
RU11 – Nyakibande Village Spring

Spring water source

Crops planted downstream of the spring

Agricultural activity was observed in the vicinity, with plots cultivated with banana plants, sweet potatoes, and other crops. Water from the spring is directed to these fields through shallow trenches, allowing continuous irrigation supported by the spring’s perennial flow.

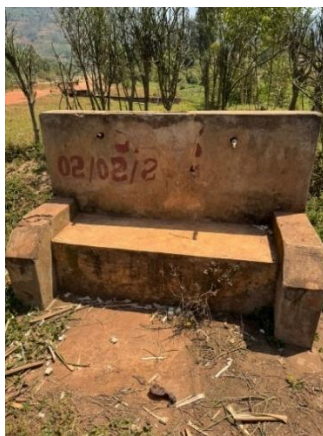
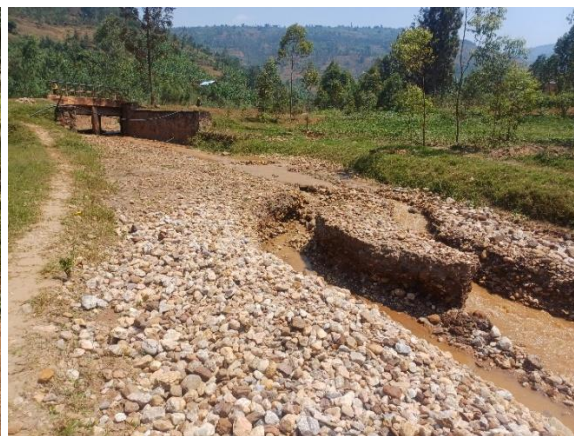
RU07 – Gisiza Village Water Collection Point

Water collection point

Mining within the Nyakibande river causing turbid water

| <p>The water collection point in Gisiza Village was non-functional at the time of the study. It was noted that no other functional water collection points were recorded in Gisiza village, although the geographical location of the village may offer natural spring alternatives which were not assessed during the study. According to available data, the alternative water sources relied upon by the community are natural springs at Rebero and Nyakibande villages, located approximately 2.2 km and 0.5 km, respectively, from the Gisiza collection point.</p> <p>During the assessment, water in the Nyakibande River was observed to be severely turbid, likely resulting from upstream sand and stone mining activities conducted by the Rutongo Business of Sand and Stone (RBSS). Subsistence farming was observed in the village, with small plots cultivated with banana plants. Local residents indicated that these crops are primarily rainfed and used for household consumption rather than commercial purposes.</p> <p>The primary concerns at this collection point are the lack of functional water infrastructure within Gisiza Village and the limited accessibility of alternative sources which may be far for community members without alternatives ways of transport. Water quality at the nearest river source is also compromised due to turbidity from upstream mining activities. Together, these factors present challenges to ensuring safe, reliable, and convenient water access for the Gisiza community.</p> | | | |

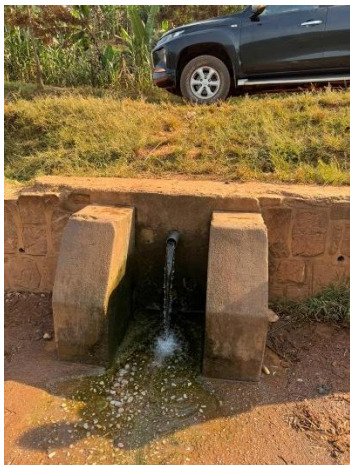
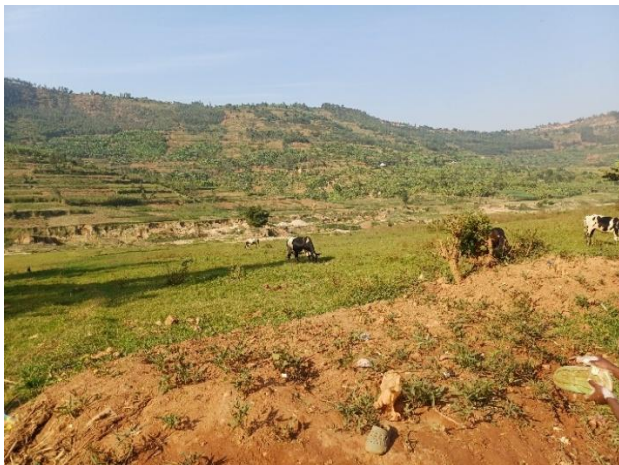
RU12 – Rebero Village Spring

| Spring water source | | Cattle grazing near the spring | |

Some crops were observed near the spring; however, the majority of the surrounding fields remain uncultivated, likely serving primarily as grazing grounds for cattle.

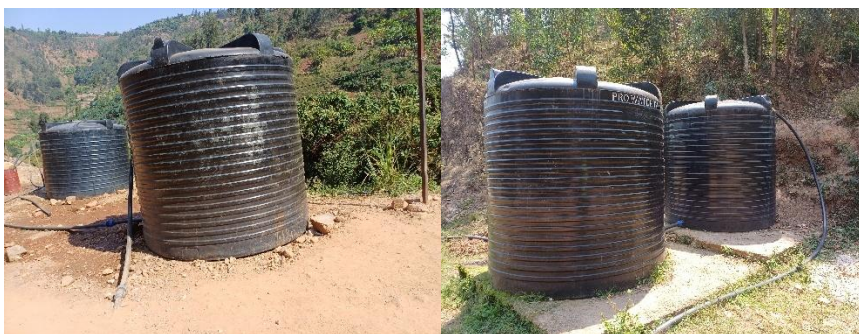
RU27 and RU28 –Water Supply Tanks at Masoro Mine

Tanks at Tunnel 11

Tanks at top of the hill
