FIELD SURVEY REPORT

TRINITY METALS

GT1377/28082025/00

This report provides an overview of the first field survey undertaken from 29 July – 5 August 2025. It provides information about three components of the Phase 1 studies namely, hydrocensus, floodline determination and sediment and hydrological modelling, that are being undertaken for the four Trinity mines namely, Rutongo, Nyakabingo, Musha and Ntungwa. The hydrocensus study will systematically gather data on community water use, water source types, and water-related issues to inform water resource management and identify areas needing supply interventions. The flood line determination study will model flood events and map flood inundation extents for major rivers affected by mining using hydrological data and terrain models, including projections under climate change scenarios, to guide ecological and engineering planning. Finally, the sediment modelling will assess current and future water flows and sediment dynamics in the catchments associated with the Trinity Metals concession areas under changing land use and climate conditions, supporting impact mitigation and sustainable rehabilitation planning.

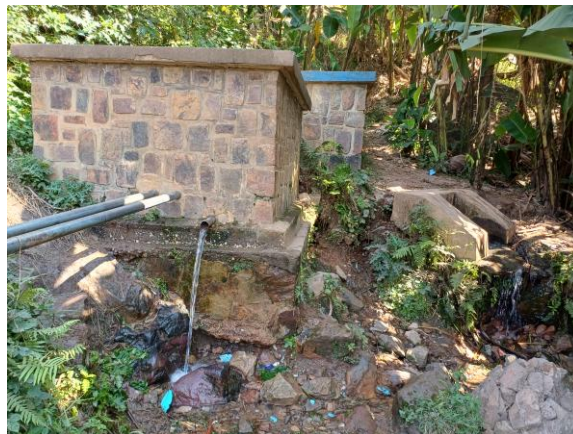
Mutagata spring source at Ruli village is a critical water source supplying Murambi, Masoro, and Kanzuzi sectors

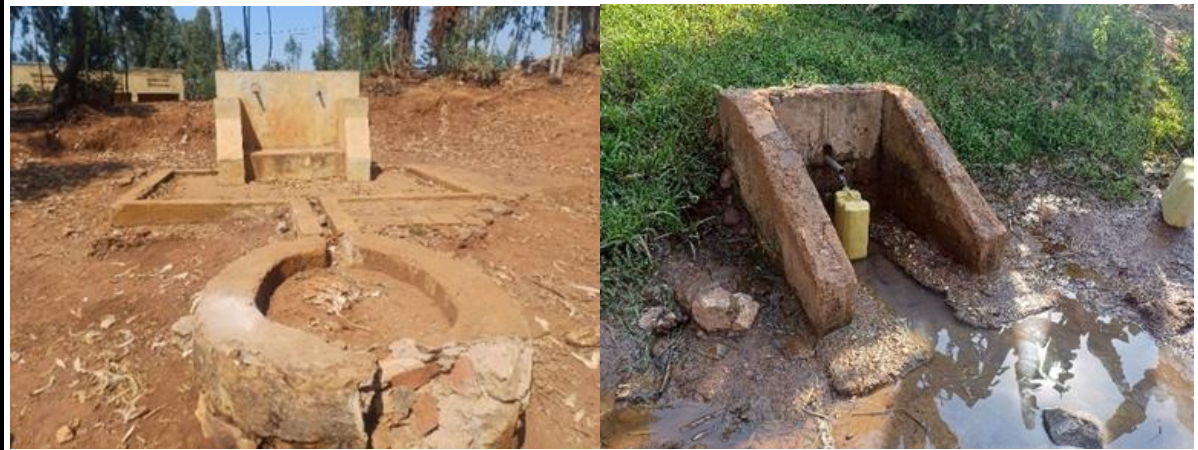
Left: Ruri village water collection, which was non-functional during the study. This was the case at a number of community water collection points as a result of infrastructure failure coupled with declining spring source yields in the dry season..

Right: Nyakibande village spring, showing typical village spring water collection point. The springs run continuously and the excess water is often directed through shallow trenches to nearby cultivated fields.

Beyond mining impacts, water supply to the villages is constrained by infrastructure challenges. Many collection points are damaged or non-functional, with some remaining dry for several years due to pump or system failures. Limited pumping and storage capacity, particularly at Mutagata spring source which supplies Murambi, Masoro, and Kanzuzi sectors, causing intermittent supply that cannot meet demand during peak or dry periods. Seasonal variability further reduces spring yields, while *Eucalyptus* plantations threaten spring yield at some sites. Accessibility is also difficult, with communities facing long and steep collection routes, while financial strain arises when residents must purchase water or rely on restricted access during periods of intermittent or no water supply at collection points near their households.

Over-reliance on a few functioning water collection points and springs highlights the need for improved infrastructure, maintenance, and additional reliable water sources within the Rutongo Mine concession area.

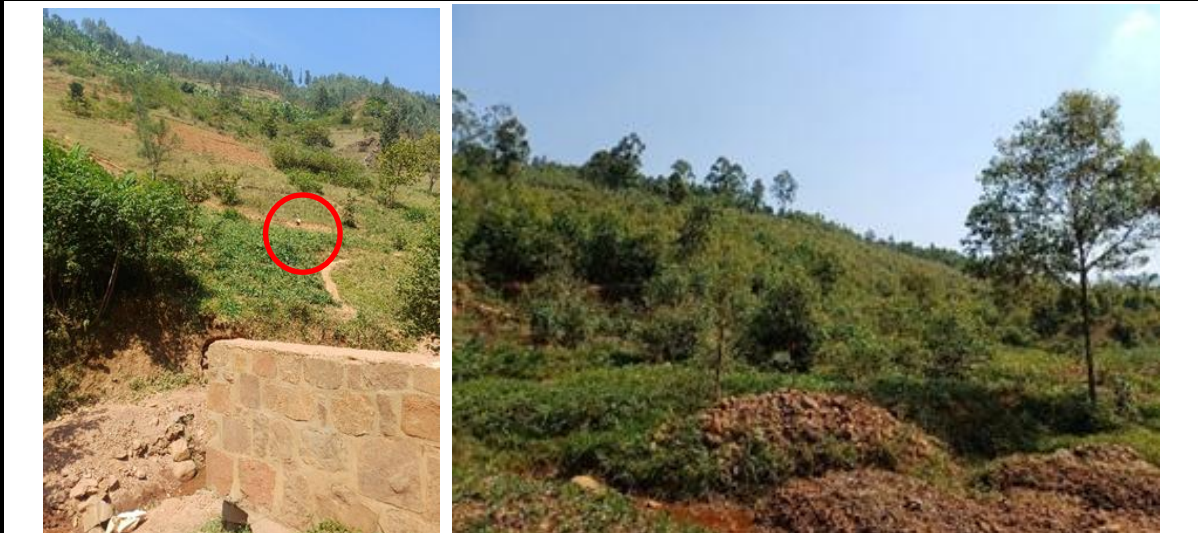
Left: Child (red circle) walking down the hill to a spring source. This is the typical journey taken by community members to alternative water sources which may be physically challenging to reach.

Right: *Eucalyptus* plantations within the catchment are a potential threat to critical spring sources, especially in the dry season.

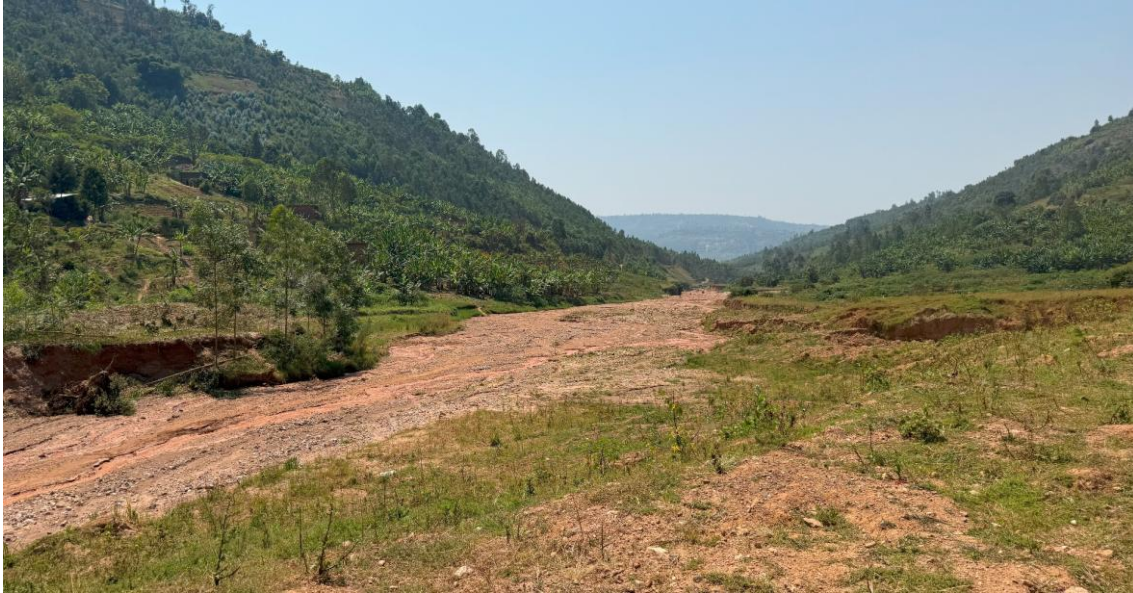
Valley adjacent to the Nyamnyumba mine in Sediment Site 1. Signs of extensive mobilisation of sediment and coarser material in the valley bottom.

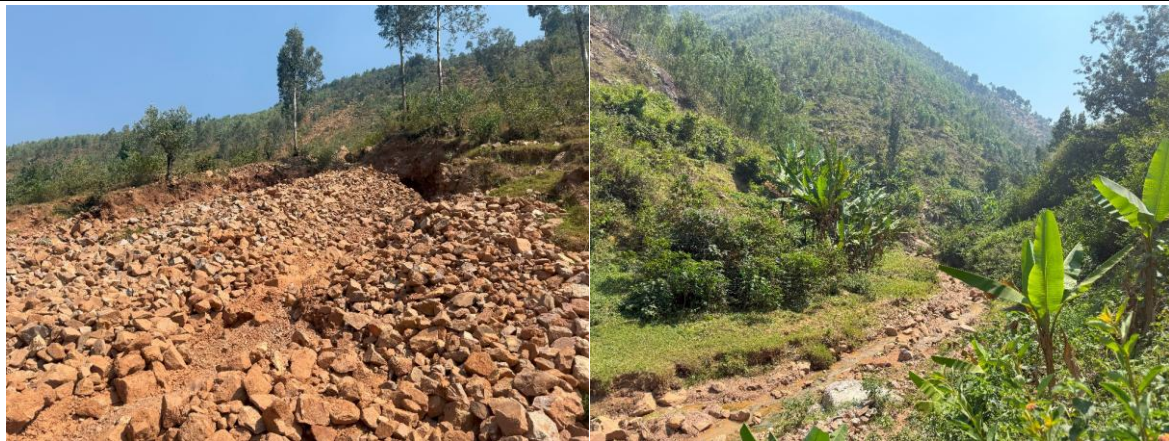
Left: Mining activities at Makogote – a clear source of large sediment to the downstream rivers at Sediment Site 3.

Right: Stream upstream of Makogote mining area – an indication of a stream that is not impacted by mining activities at Sediment Site 3.

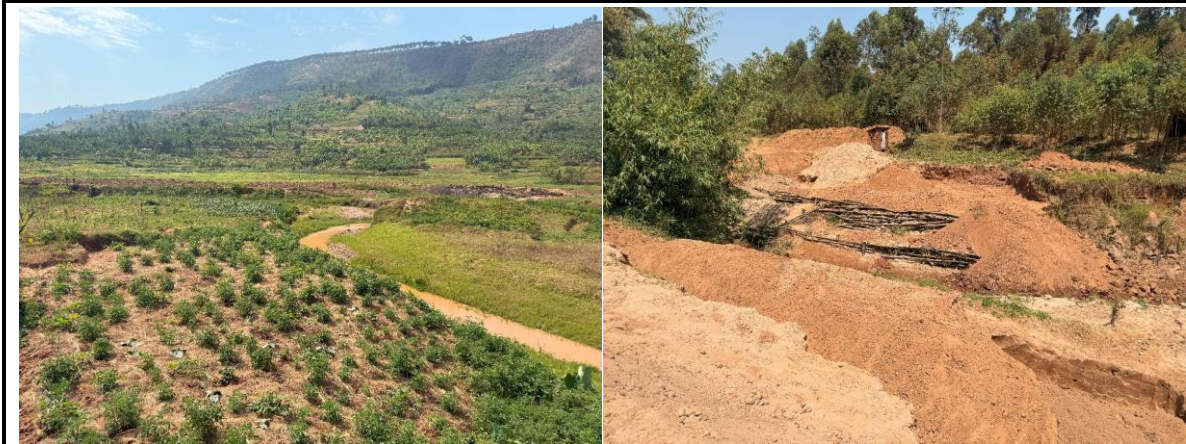
Left: The Rusine River upstream of the Karambo mining area, relatively unaffected by illegal mining and RBSS activities, at Sediment Site 4.

Right: The Rusine River downstream of the Mahazehe mining site and upstream of the Nyabugogo confluence, at Sediment Site 5.

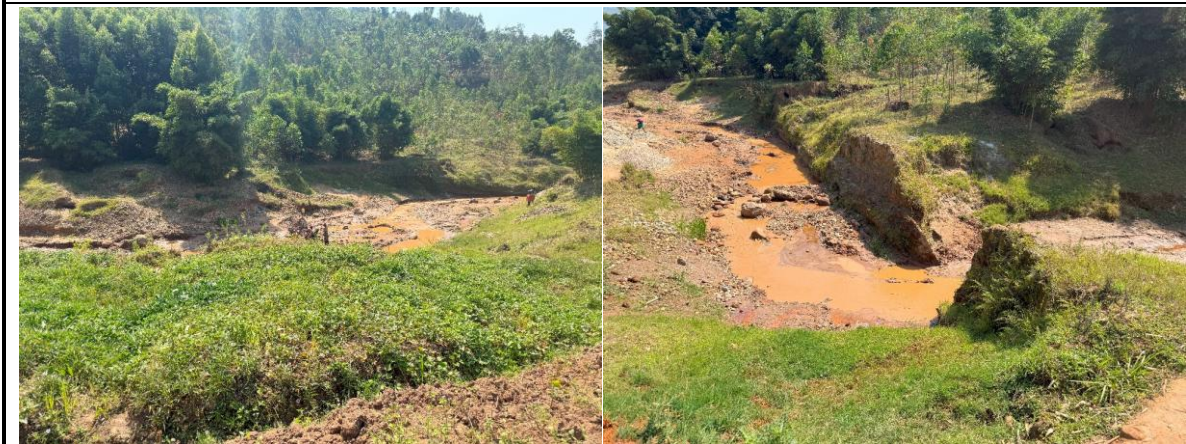
Left: Area of deposition below the Masoro mining area where RBSS mining is occurring in Sediment Site 6.

Right: Directly downstream of left picture, these depositional areas consistently coincided with geological control points pictured here.

To effectively manage sediment flux and safeguard freshwater ecosystems, it is essential to establish clear and enforceable standard operating procedures (SOPs) for sand and aggregate mining activities. Particular attention should be given to valley-bottom areas where illegal mining and RBSS operations are prevalent. These activities are currently exerting a disproportionately negative impact on freshwater systems. Implementing regulatory frameworks and accountability mechanisms in these zones could significantly improve ecosystem health and resilience.

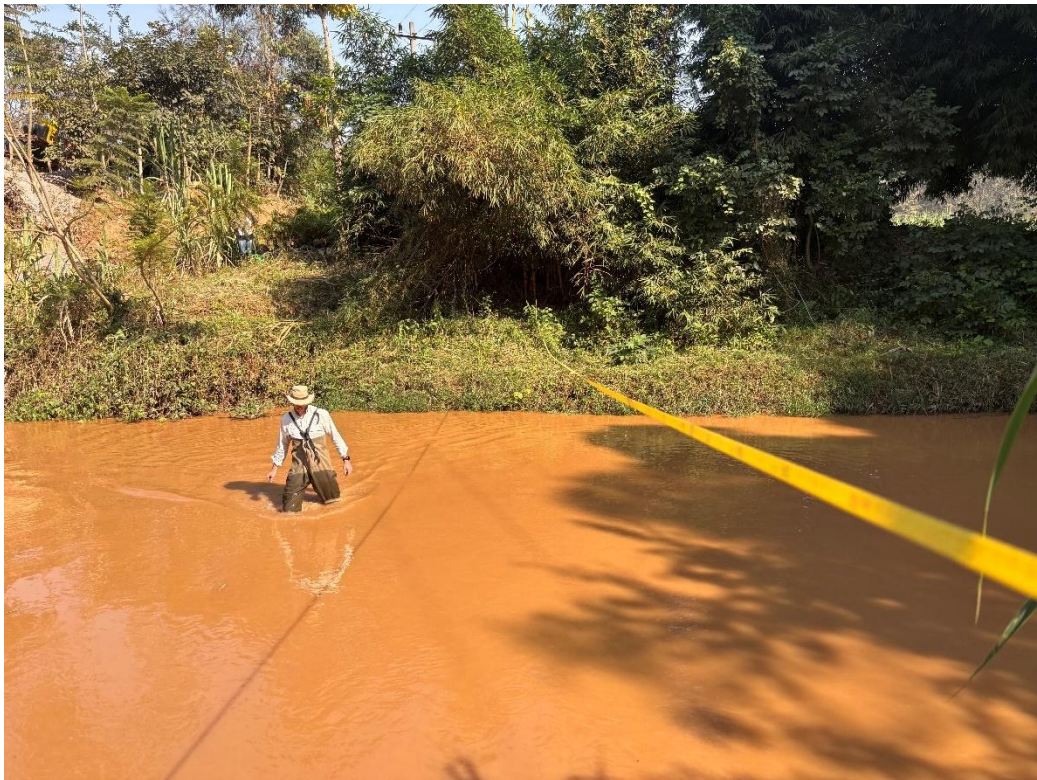
Photographs showing tape measure erected across the channel to indicate location of the cross section. The cross-sectional profile of the channel was surveyed using a high accuracy GPS device and a sonar device.

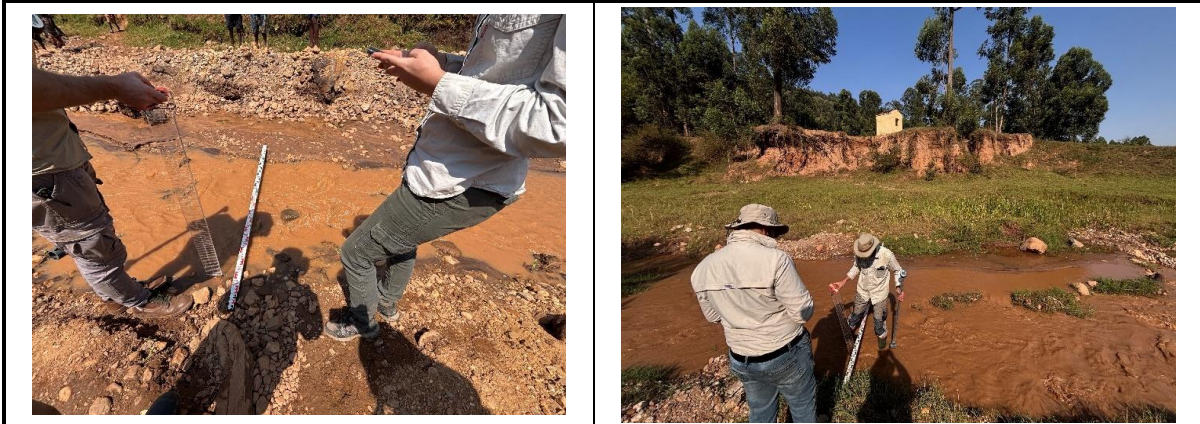
Both photographs show team members measuring water depths and velocities in the watercourse.

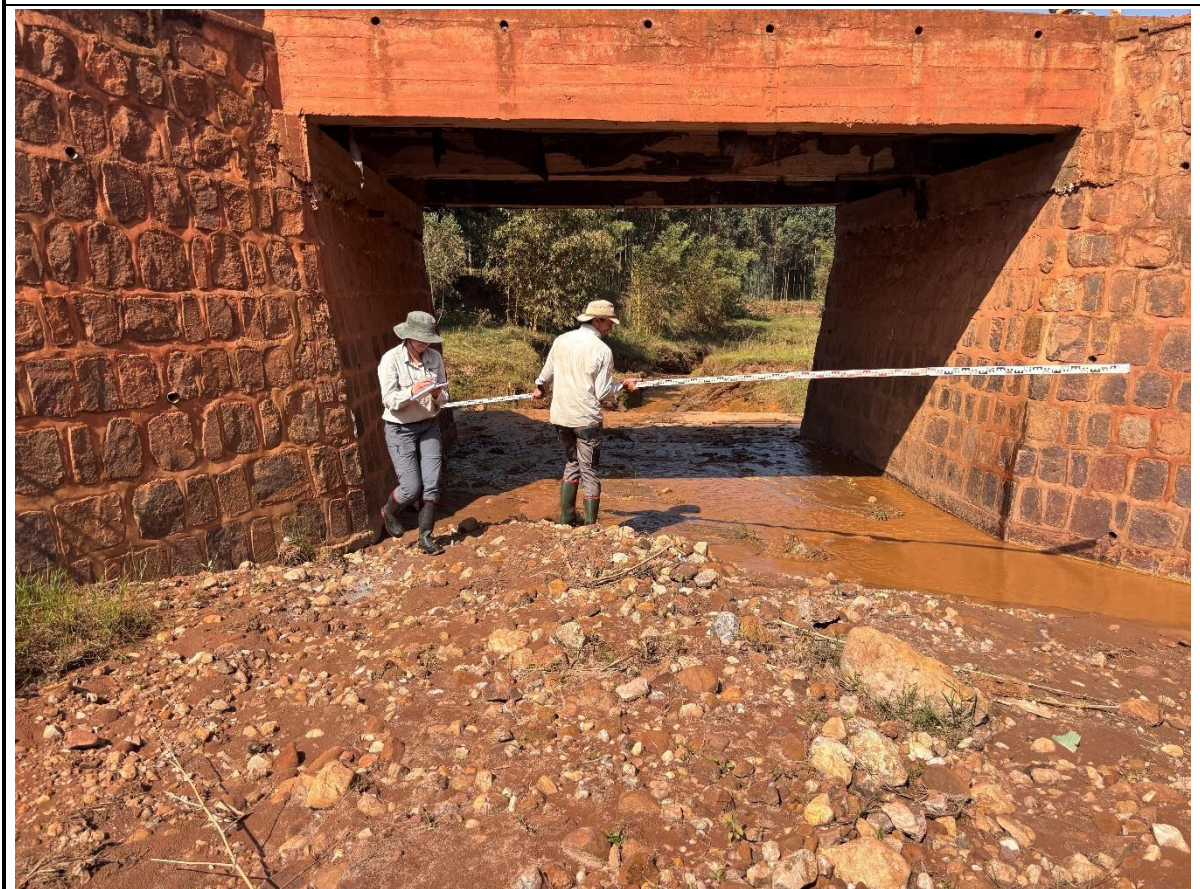
Photograph showing team members measuring the dimensions of hydraulic infrastructure. The length, width, height and invert level of the bridge culvert was surveyed.

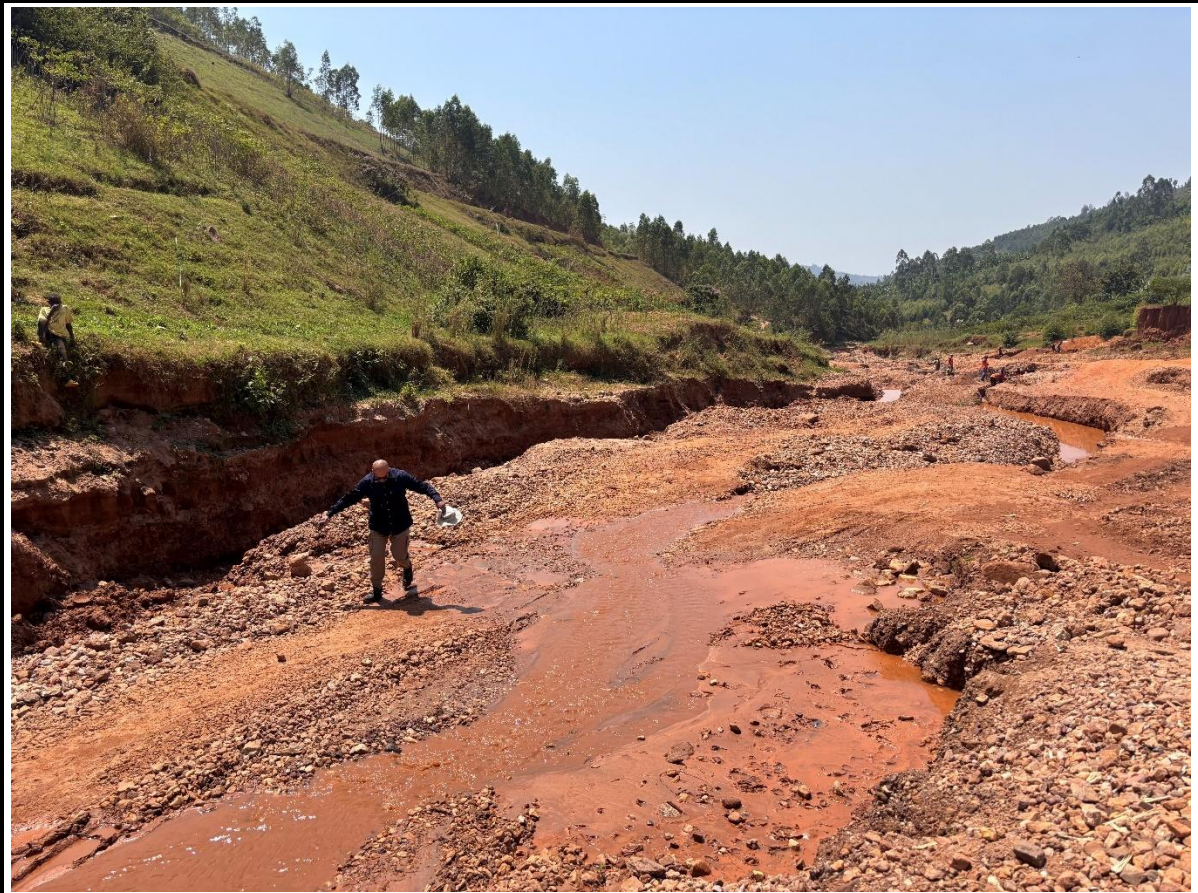
Photograph showing highly modified channel due to sand/aggregate mining.

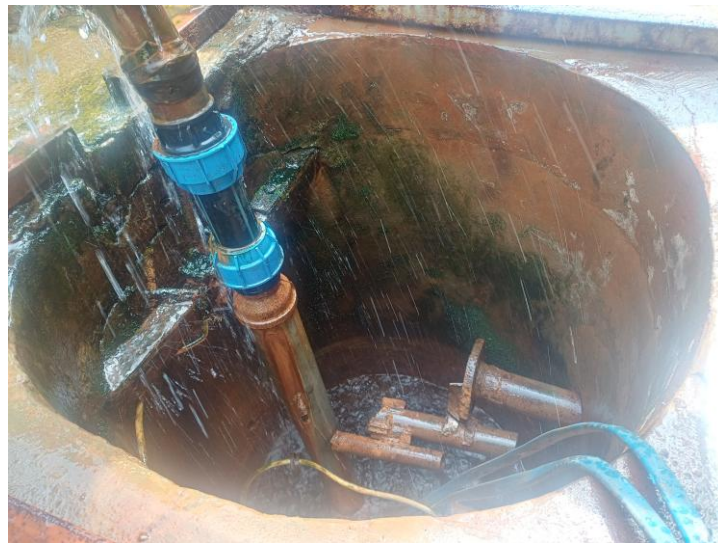
Gahoko spring source which supplies the distribution tanks at Gateka and Akabare where water is further supplied to the various village water collection points.

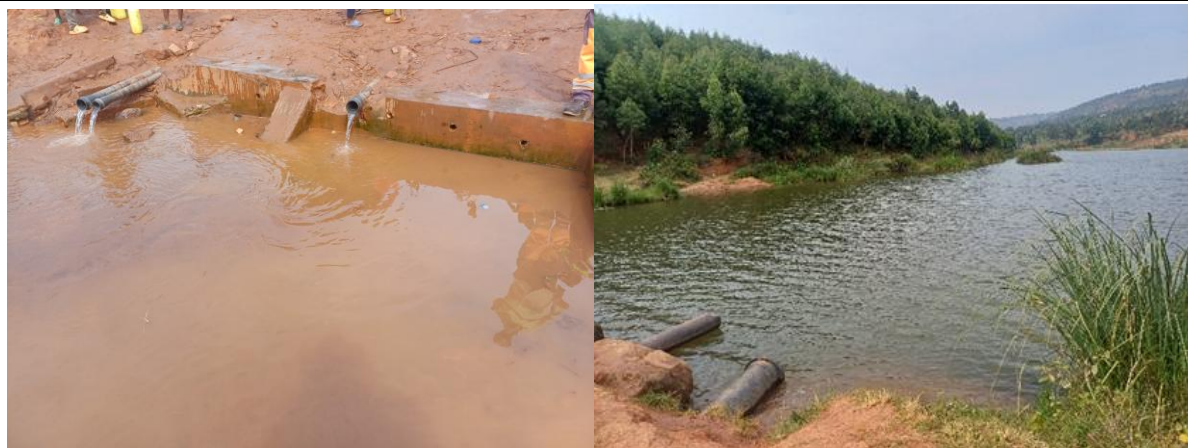
Left: Muhogoto village spring, which was functional during the study. This spring is the main water source for the village. The water is used for domestic purposes.

Right: Bisinia Dam, used as an alternative water source by community members. Some community members were observed to be washing clothes here. Community members reported to be using the water from the dam for domestic purposes. They boil the water before use. Overflow from the dam is directed to cultivated fields via shallow trenches.

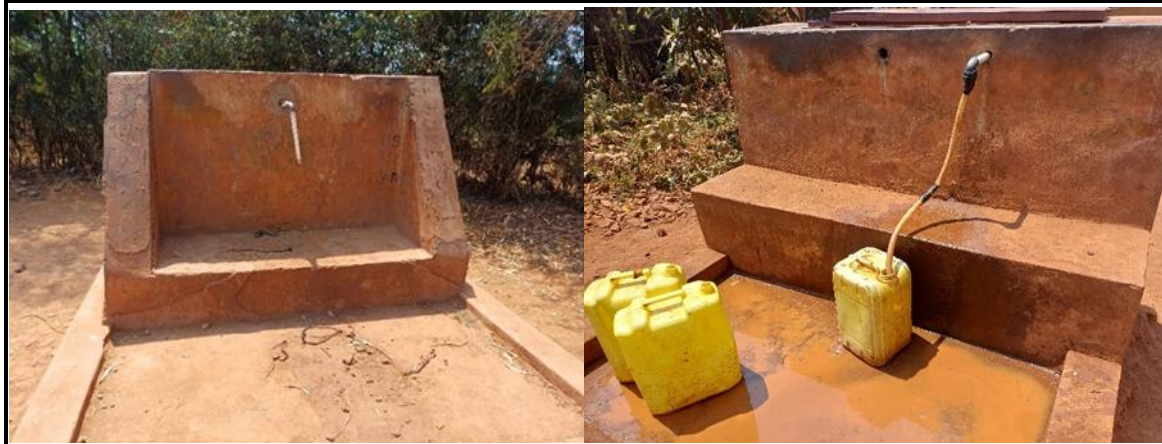
Left: Kagarama village water collection point, observed to be non-functional during time of field survey. This point is supplied by the Akabare village distribution tank, which was still being filled during the time of the study.

Right: Rugabano village water collection point was operational during the time of the field survey, with a flow rate of 0.5 litres per second.

While the water system ensures broad coverage, its functionality is heavily dependent on pumping schedules and the refilling of distribution tanks, which results in intermittent supply across villages. Several collection points were observed to be non-functional at the time of the assessment, highlighting the system's vulnerability to operational delays.

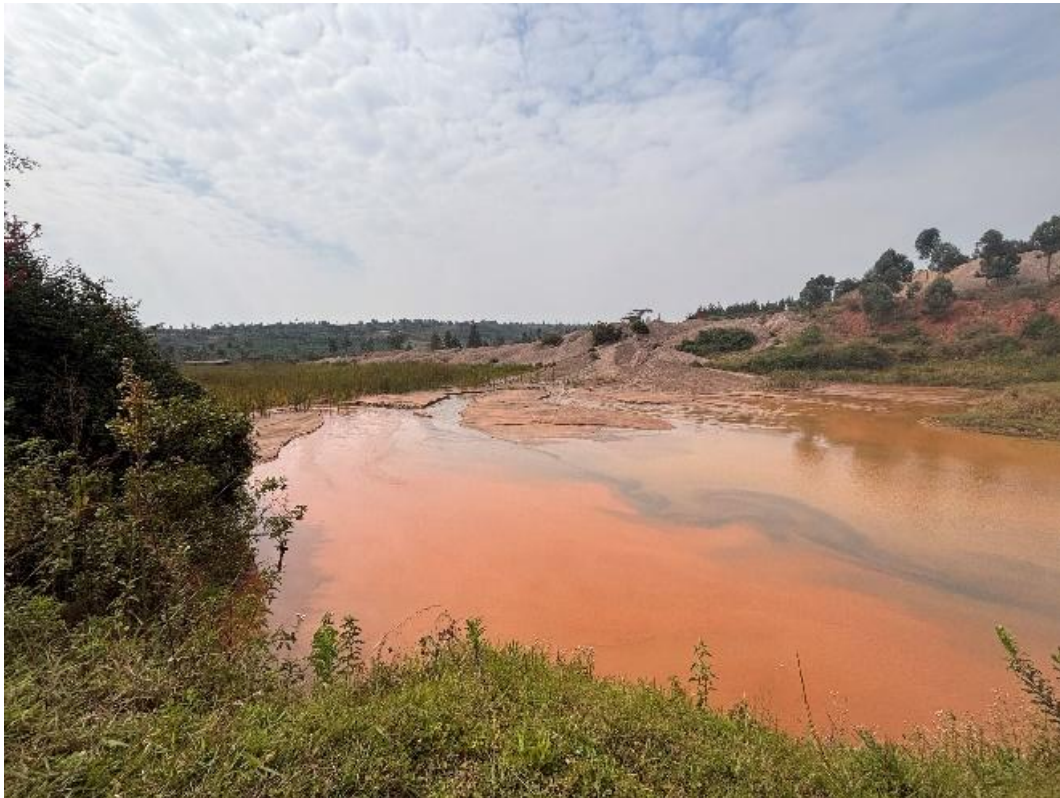
Photograph showing the tailings dam located on the Musha mine.

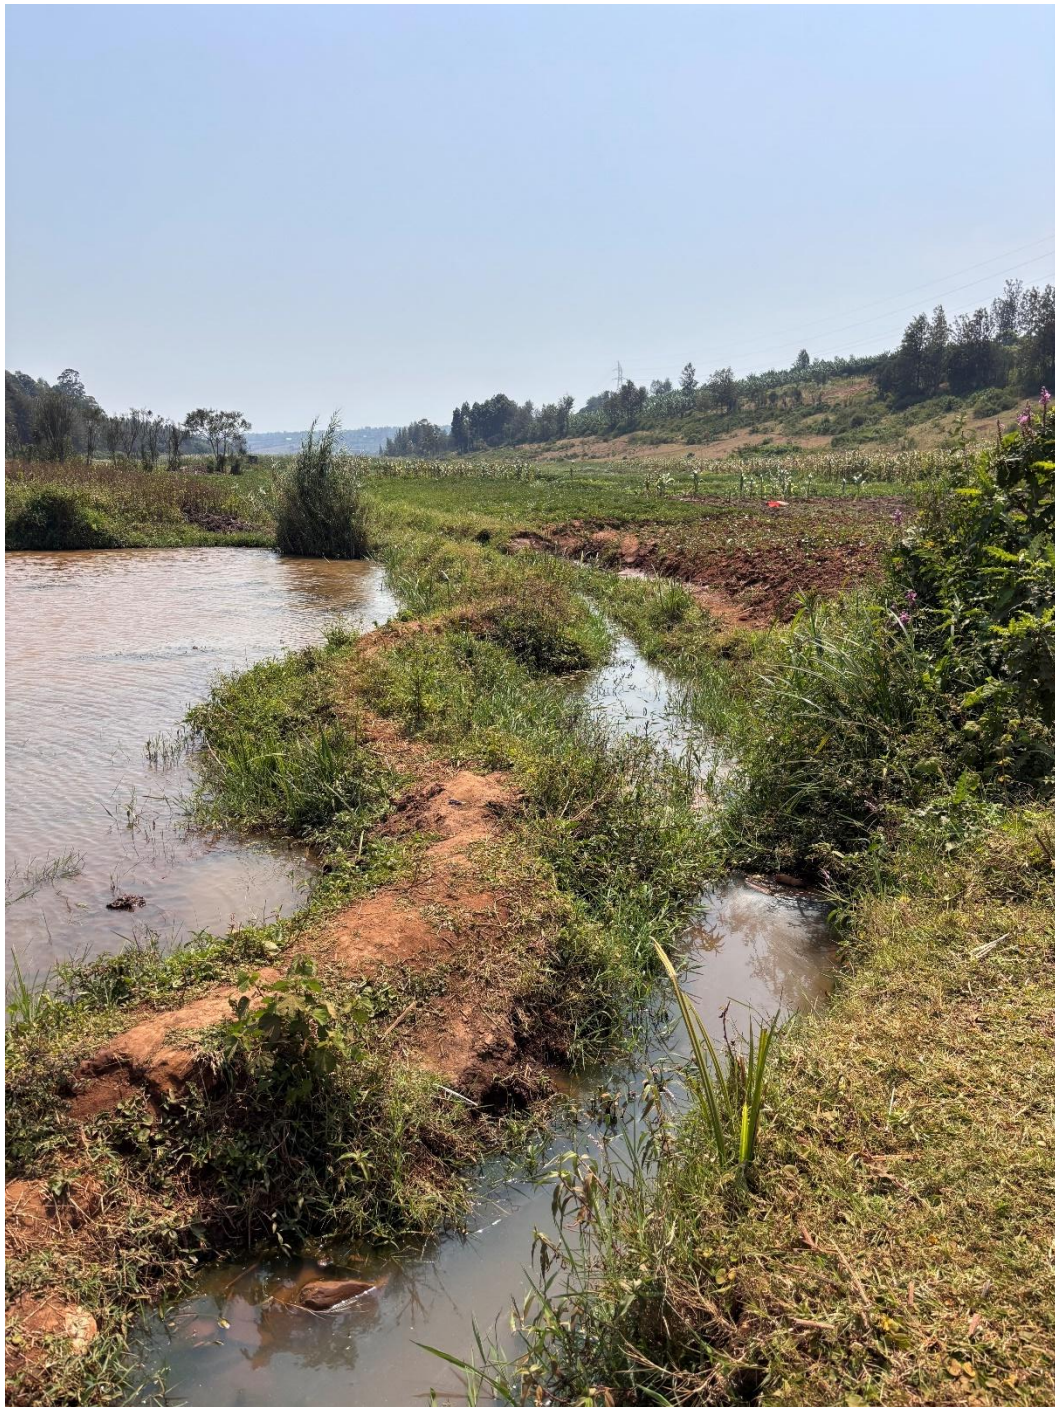
Photograph showing water being diverted into cultivated land.

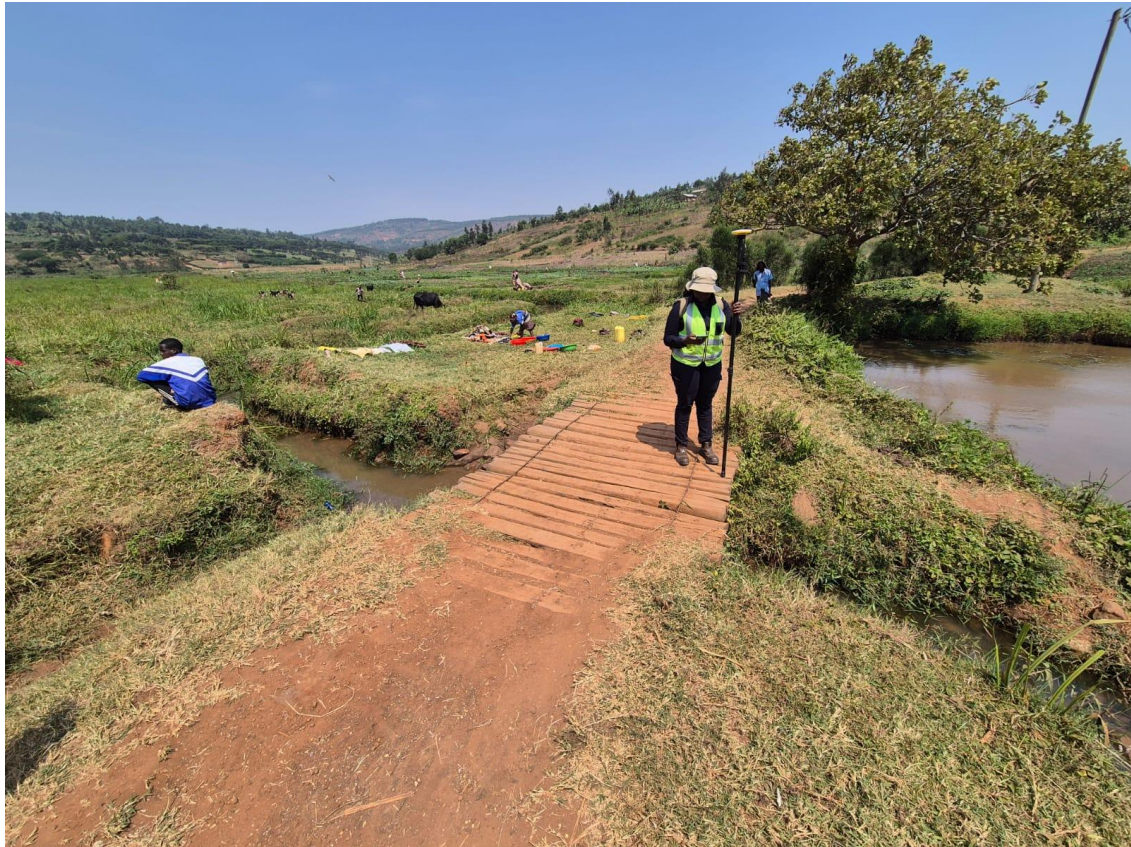
Photograph showing team member surveying pedestrian crossing erected over watercourse.

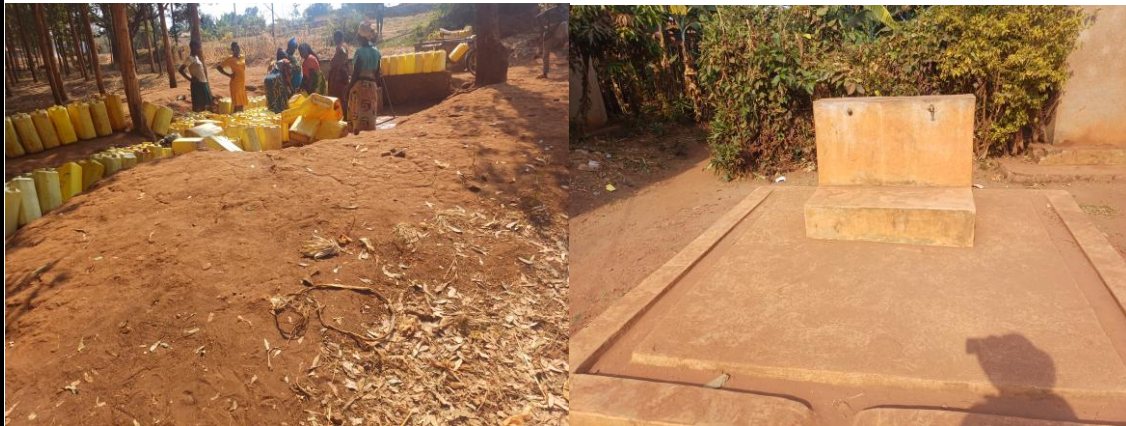
Left: Ntunga village water collection point. Appears to be the main water collection for the village as there were a lot of containers and community members compared to other points. Villages indicated that the actual water source was located at Bicumbi.

Right: Water collection point at Ntunga village reported to have water only once a month by locals. An alternative for the village is a private tank located in a household where locals pay 50 francs for every 20 litre container. Another alternative is at Kukariba spring which is a two hour walk away. Other water collection points in Ntunga and Ahoryahoze villages are also used as alternatives.

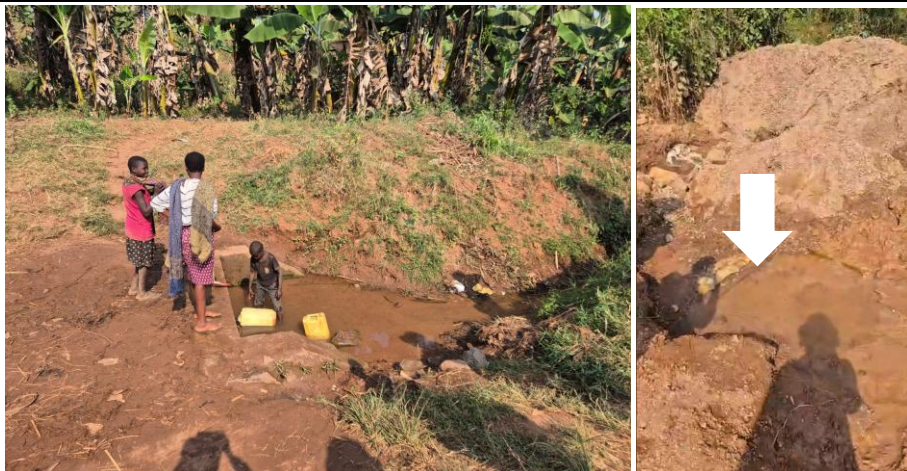
Left: Kabacuzi village spring used for domestic purposes by the community members

Right: Hand dug well in Kabacuzi village used to wash clothes

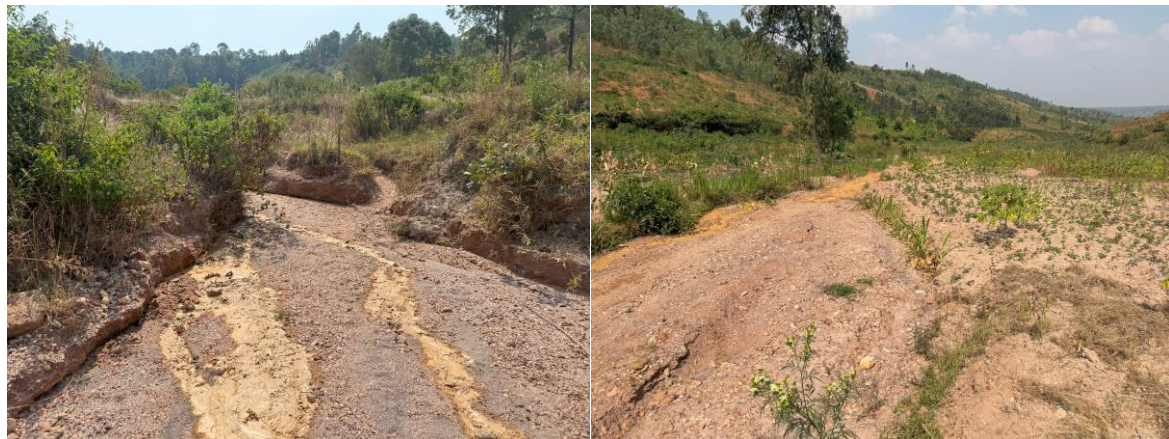
Left: Approximately 100m downstream of the tailings discard facility, which is located at the head of the stream system, a large area of erosion was observed along with a yellow/olive yellow residue in the most recent channel.

Right: The top portion of the stream is characterised by a series of alluvial fans which are characterised broadly by a gently sloping depositional ‘head’ and a slightly steeper and erosional ‘toe’. These fans will slowly transport material down the valley in a seasonal ‘conveyor belt’.

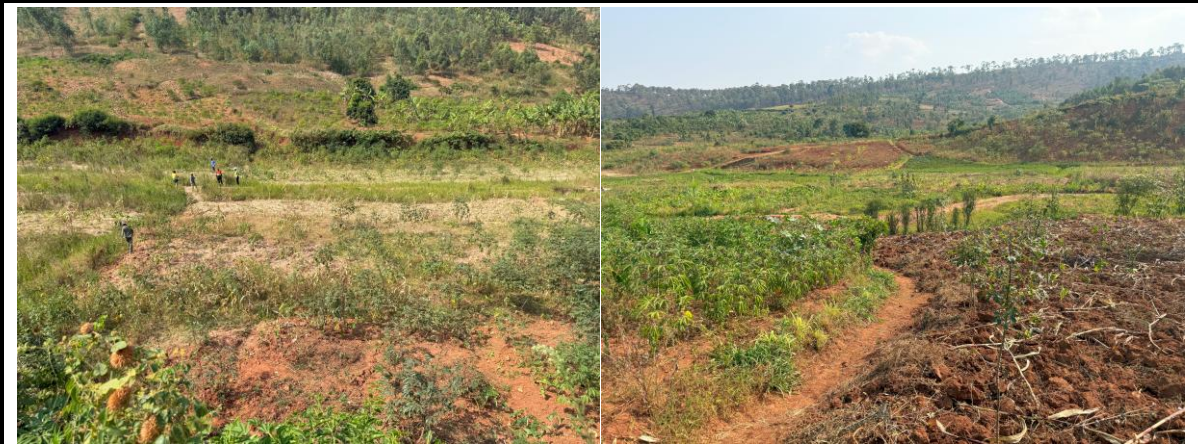
Left: There is still evidence of deposited material originating from the mining operations approximately 650m downstream of the tailings discard facility.

Right: It is only approximately 850-900m downstream of the mining operation where signs of deposition originating from the Ntungwa mining operation cease.

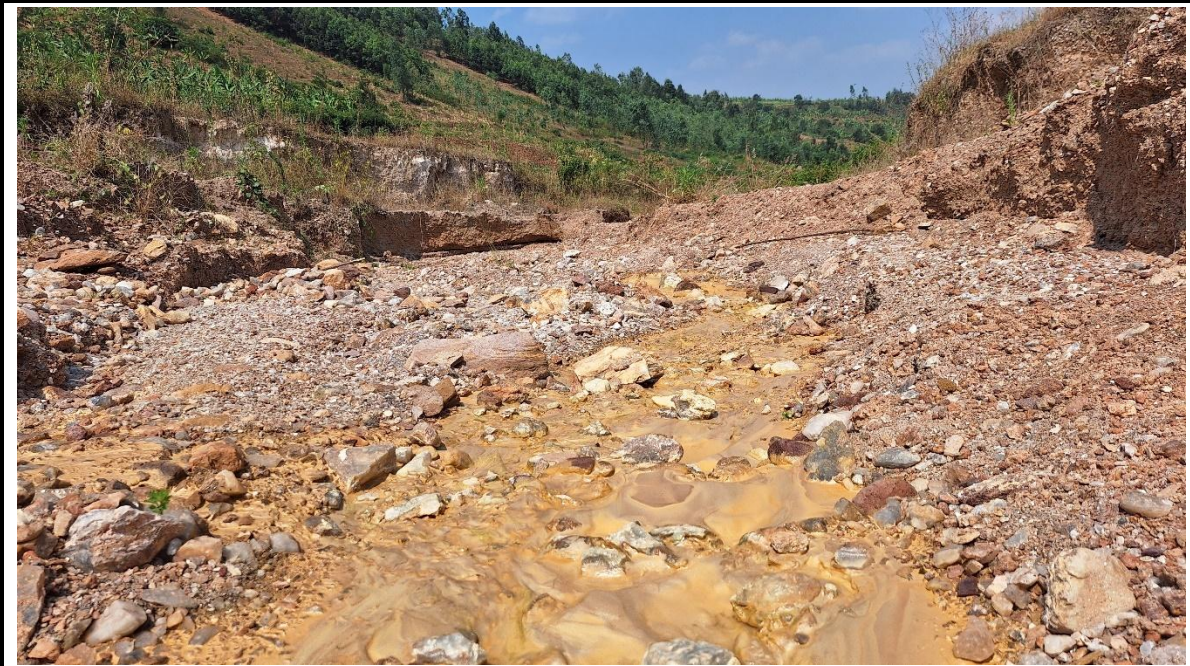
Photograph showing dry channel bed with mineral deposits.

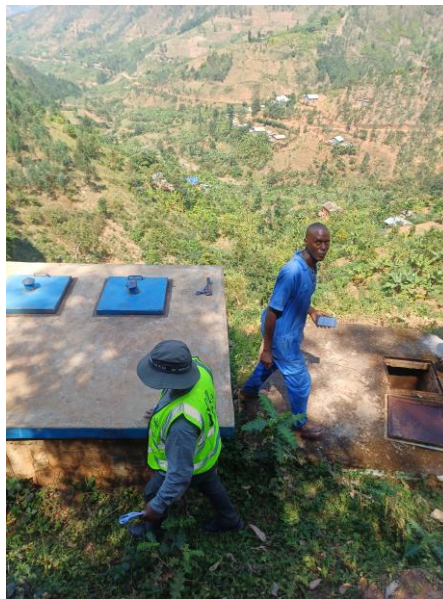
Field team at Kilikumuryango water source and distribution tanks which provide water to the water collection points at villages downstream of the mine.

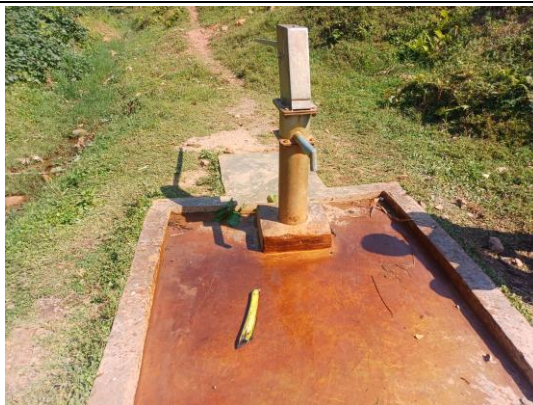
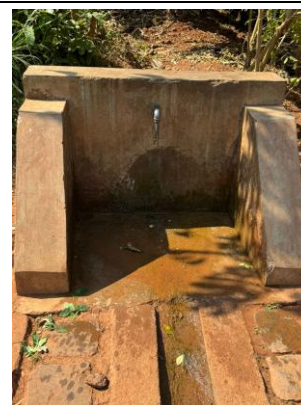
Left: Mwagiuro and Bugarura villages handpumped borewell installed by Trinity Metals Nyakabingo. The water from this source was deemed unuitable for consumption as a result of elevated manganese and iron concentrations.

Right: This water collection point is located in Mwagiuro village across the Nyakabingo River and on the opposite hill to the borewell (image left). This water collection point is supplied by the Kilikumuryango water source a few meters uphill from this point.

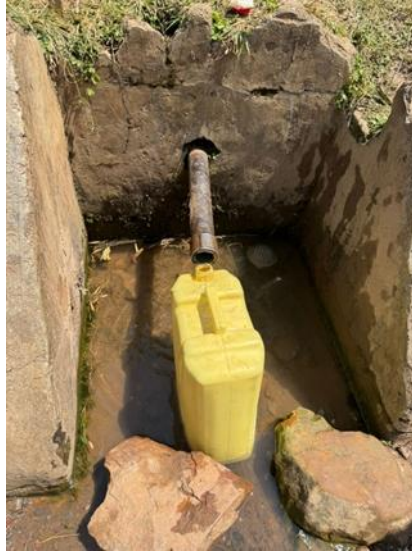
This spring is located at Mwagi village, approximately 0.5km downstream of the Nyakabingo mine and approximately 200m from the mine settling dam. The proximity of this source to the mine puts it at risk of contamination, and as a primary water source for the villages nearby, a safe alternative water source is needed.

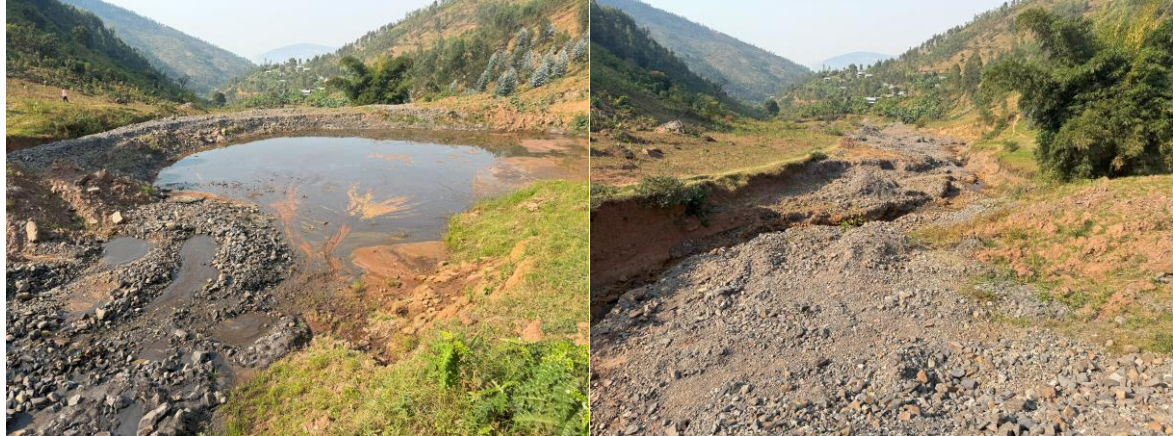
Left: One of the tailings dams downstream of the mining area. Extensive sediment deposition has already occurred in this dam.

Right: Downstream of the dam pictured on the left is an extensive area of deposited stone and large cobble sediment with a deepening erosional channel cutting its way through the deposited material.

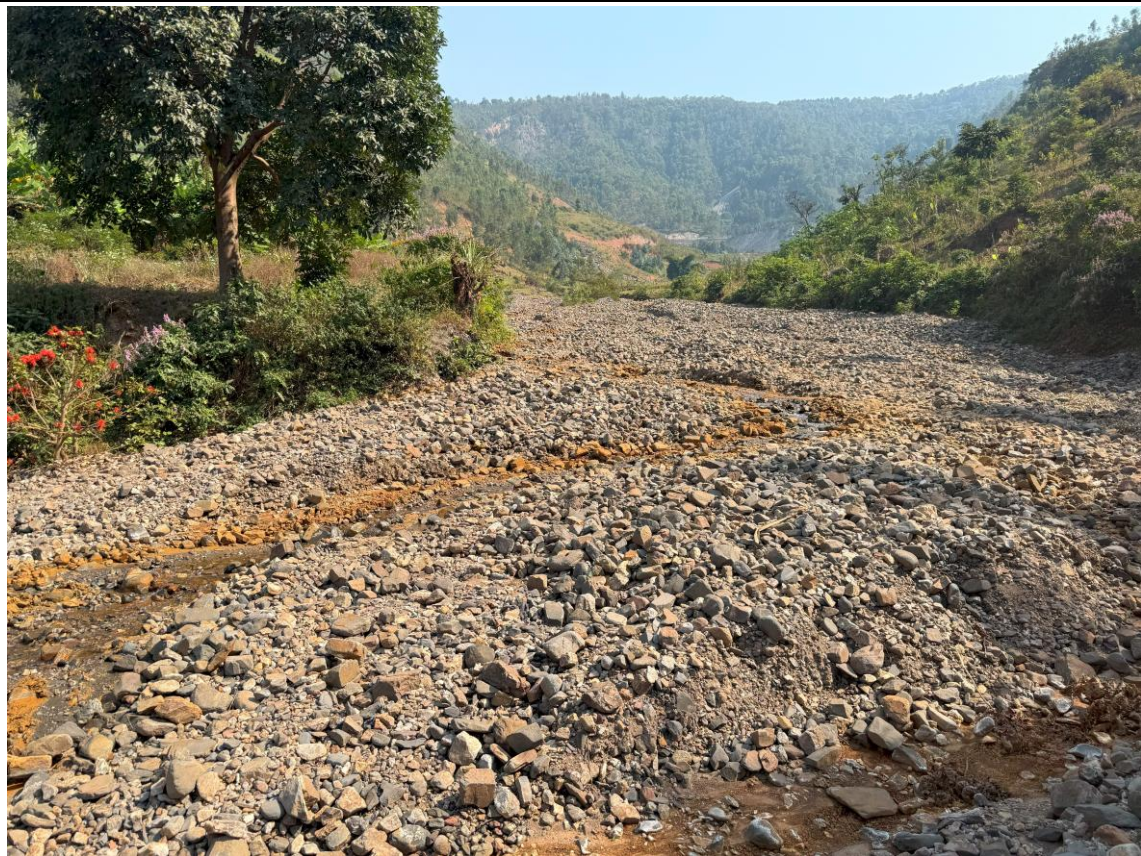
Photograph looking upstream towards the Nyakabingo mining area, depicting the deposited material which has originated from that valley-head. Note the distinct lack of fine material – indicating the erosive force and sediment transport potential of flood flows down this valley.

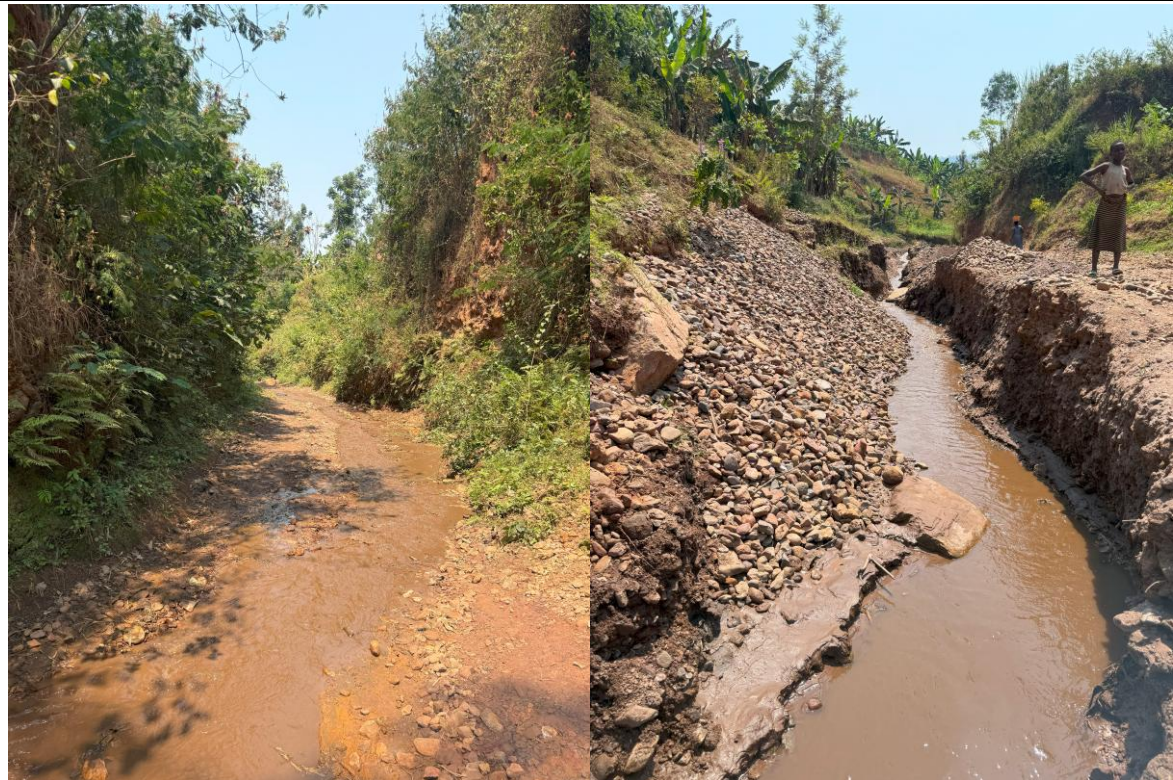
Left: Little evidence of large cobble and rock material deposited from the mining activities upstream. Note the colour of the water indicating a much greater degree of fine sediment transport (both as a result of increased flow and availability of fine sediment).

Right: Mining of the fine material and aggregate starts approximately 2km downstream of the mining area.

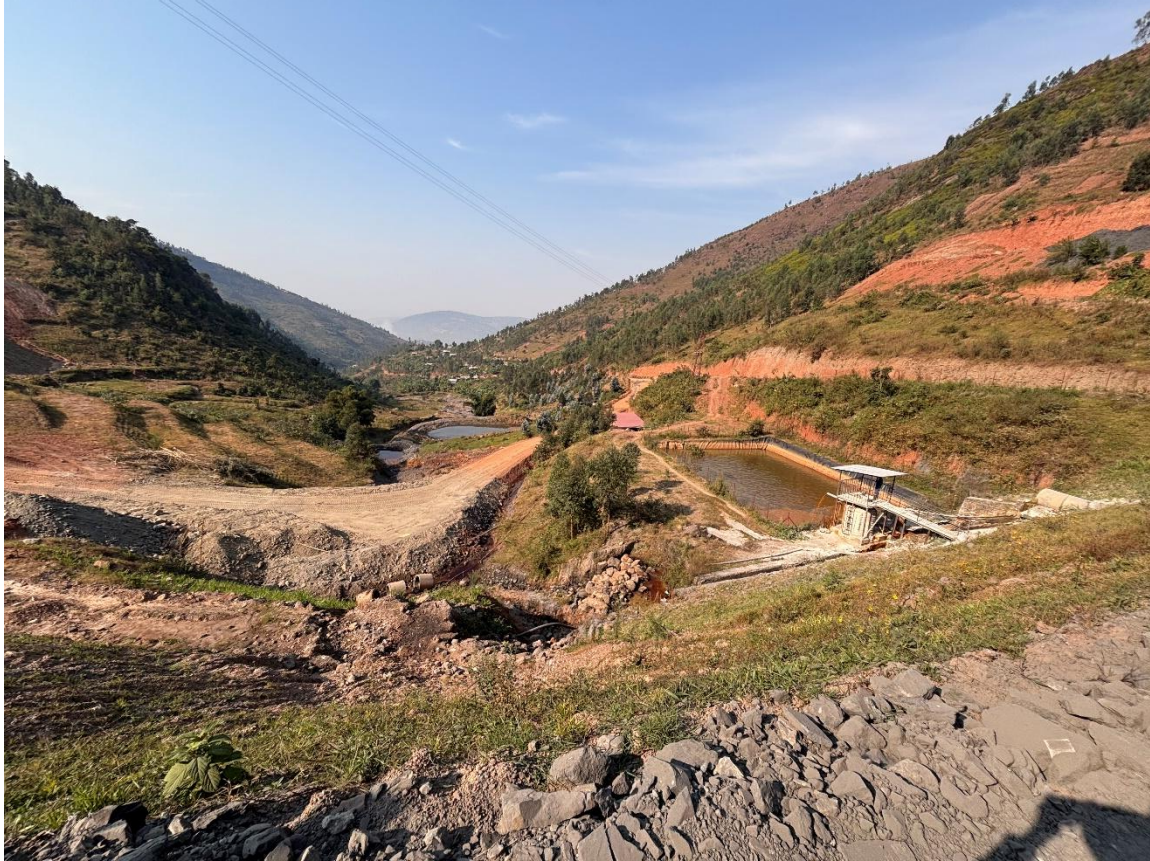
Photograph showing tailings dams at the top of the system.
