FIELD SURVEY REPORT

TRINITY METALS

GT1377/28082025/00

This report provides an overview of the first field survey undertaken from 29 July – 5 August 2025. It provides information about three components of the Phase 1 studies namely, hydrocensus, floodline determination and sediment and hydrological modelling, that are being undertaken for the four Trinity mines namely, Rutongo, Nyakabingo, Musha and Ntungwa. The hydrocensus study will systematically gather data on community water use, water source types, and water-related issues to inform water resource management and identify areas needing supply interventions. The flood line determination study will model flood events and map flood inundation extents for major rivers affected by mining using hydrological data and terrain models, including projections under climate change scenarios, to guide ecological and engineering planning. Finally, the sediment modelling will assess current and future water flows and sediment dynamics in the catchments associated with the Trinity Metals concession areas under changing land use and climate conditions, supporting impact mitigation and sustainable rehabilitation planning.

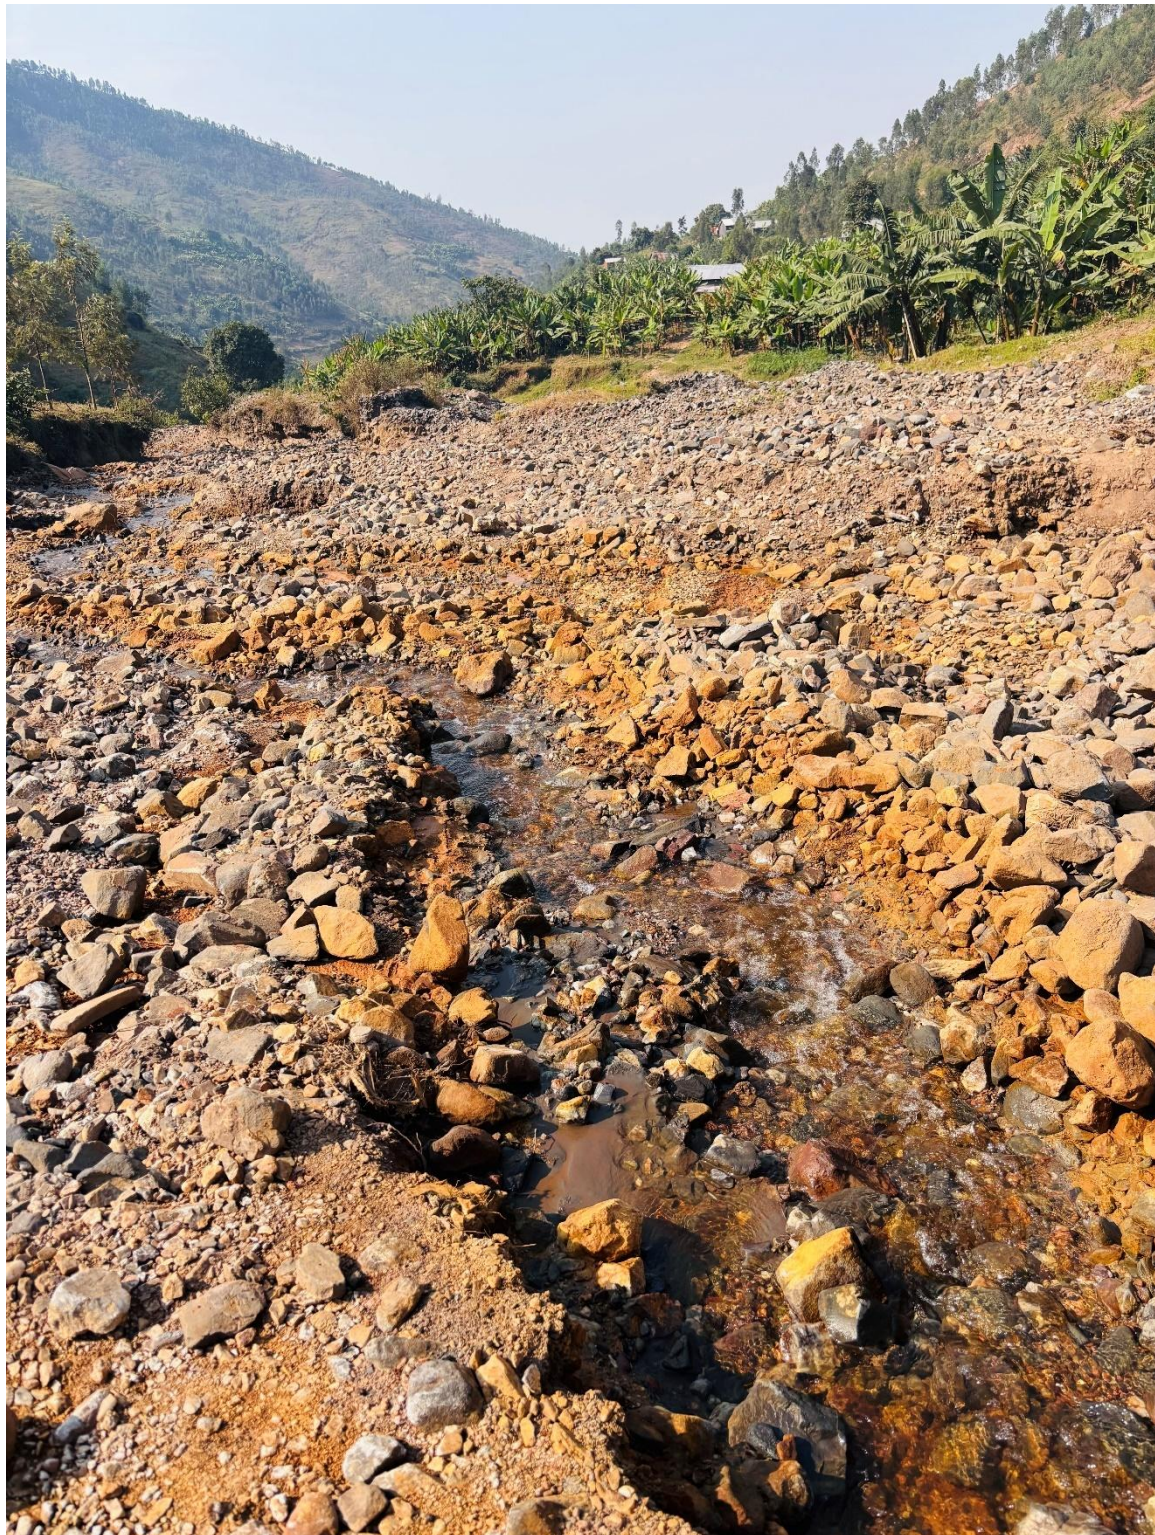
Photograph showing tailings deposits in the watercourse.

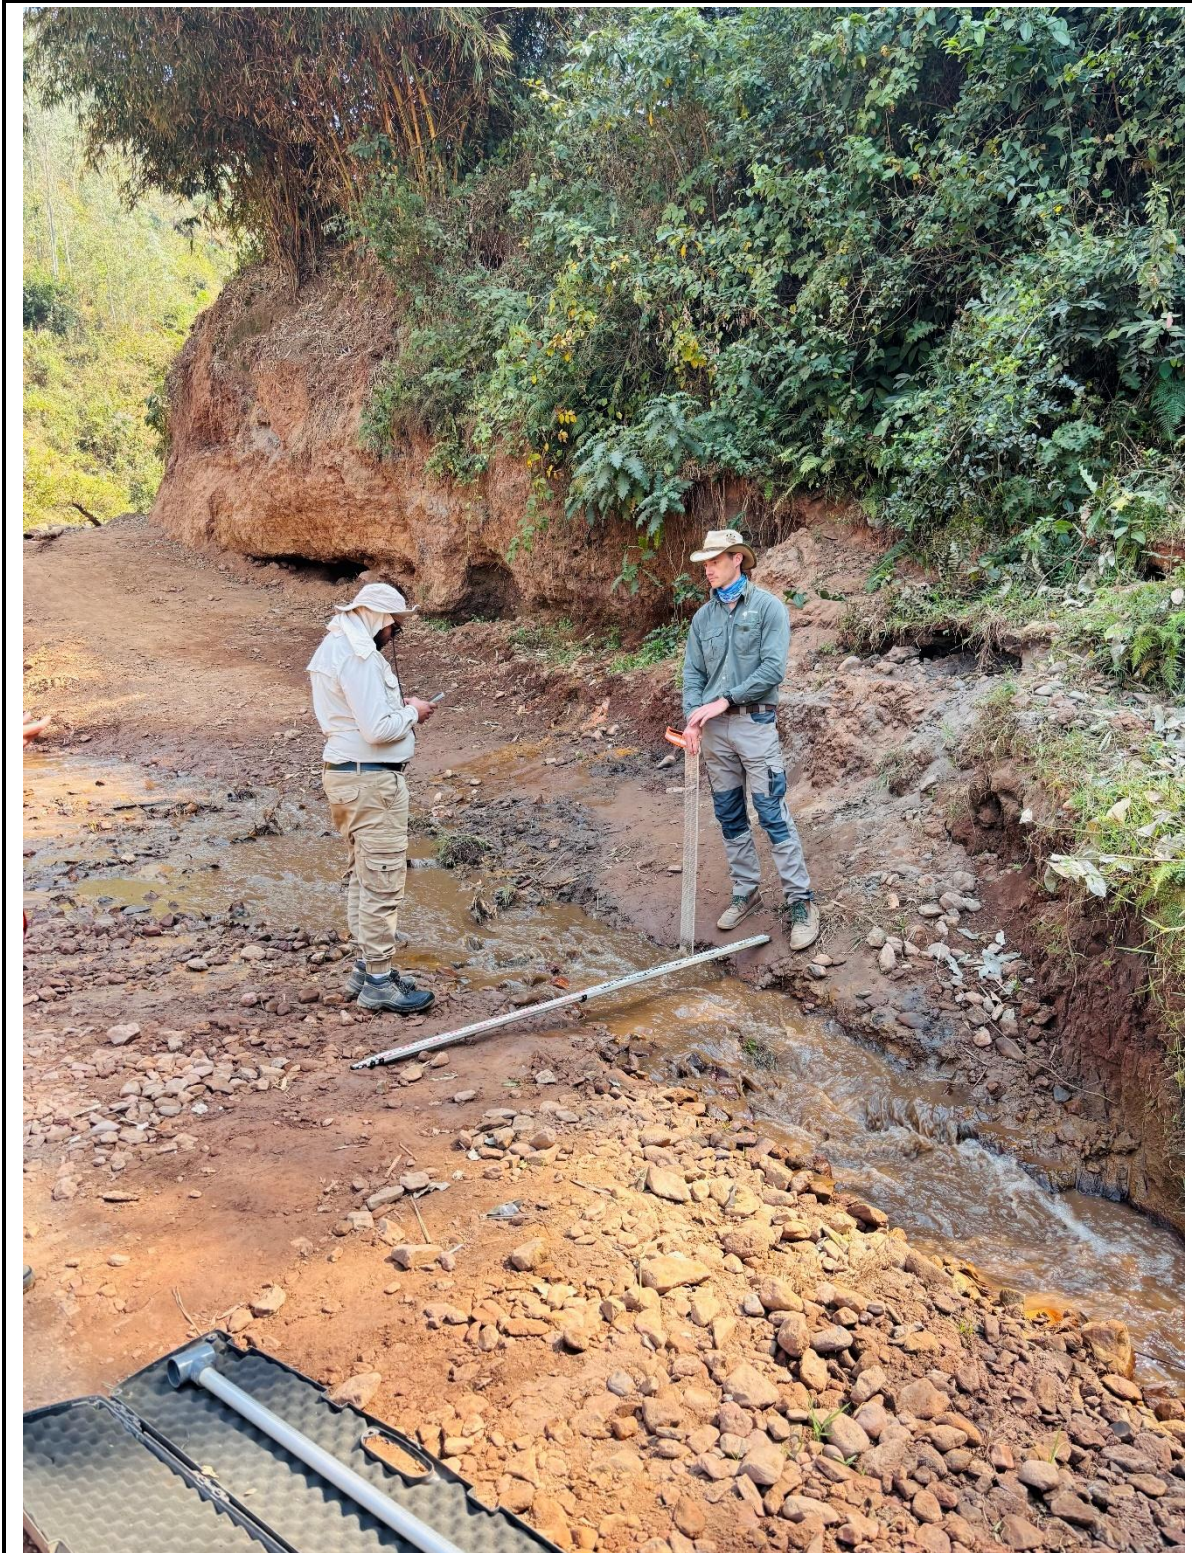
Photograph showing team members measuring waters depths and velocities in the watercourse.
