# FIELD SURVEY REPORT

## TRINITY METALS

GT1377/26112025/01

This report provides an overview of the field survey undertaken from the 11<sup>th</sup> – 19<sup>th</sup> November 2025. It provides information about the freshwater ecosystem assessments associated with Phase 1 of the project, that are being undertaken for the four (4) Trinity mines including Rutongo, Nyakabingo, Musha and Ntunga.

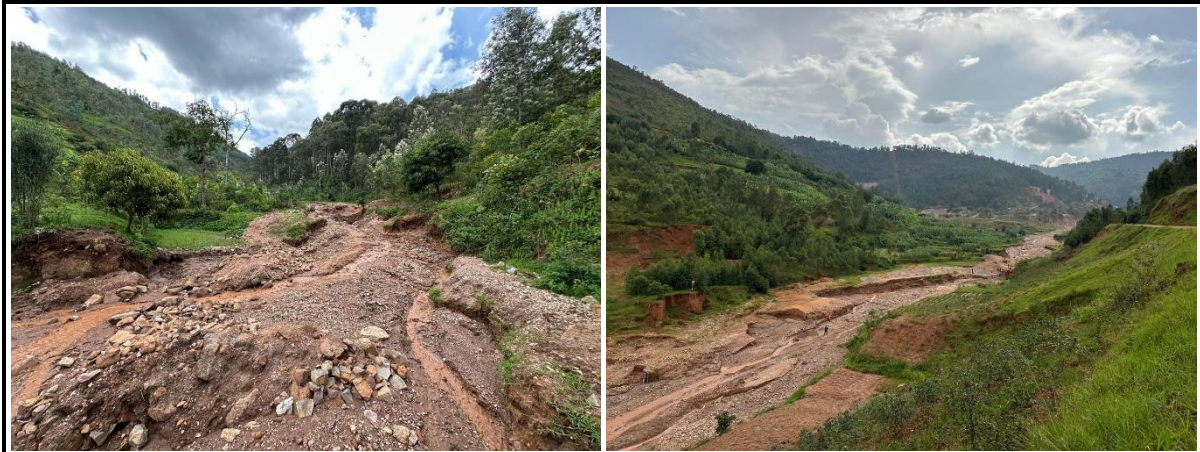
Illegal mining along the Gisanse River, tributary of the upper Rusine River, which adds to the disturbance and alteration of river habitats (left). Impacts from mining (both illegal mining and Trinity operations) and RBSS activities extend down the length of the Rusine River (right).

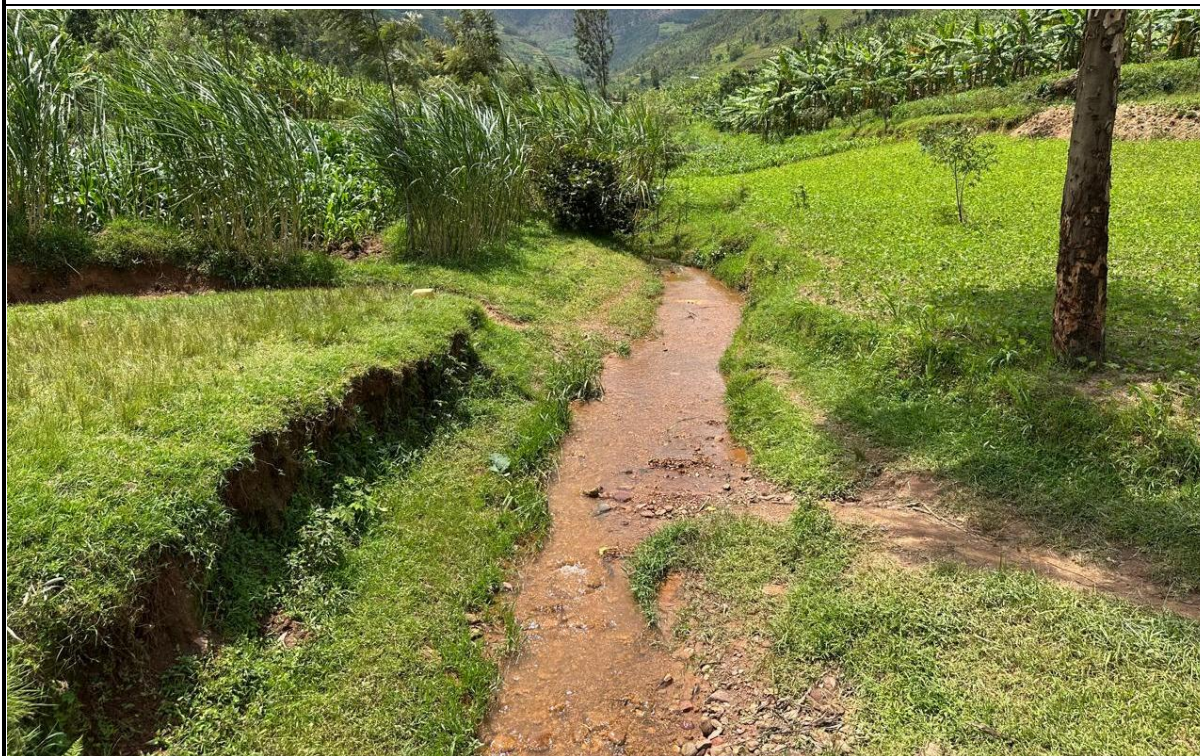
Few rivers, such as the Nyiramududu River (tributary of the Rusine River), are in a noticeably better condition, and supported a significantly higher number of aquatic macroinvertebrates, providing a useful benchmark to compare other systems in terms of desired river health.

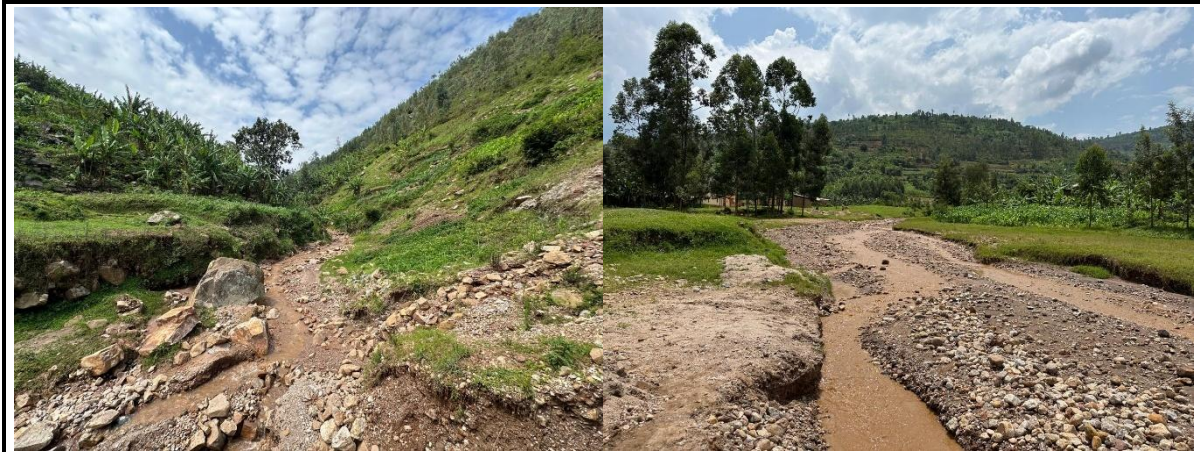
The Nyirabukingure River system upstream of the Rutongo Mine Karambo Site is also impacted by illegal mining activities (left). Immediately downstream of Karambo mining operations, the system is heavily impacted by RBSS activities, which extend all the way to the Rusine River confluence (Right).

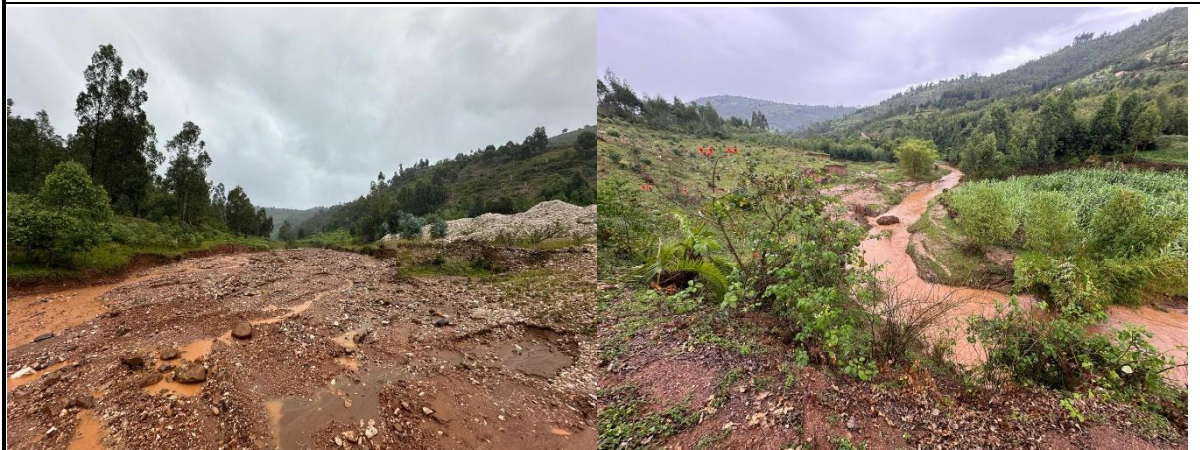
The upper Mulindi River, just downstream of the Rutongo Mine Masoro Site, is also extensively mined by RBSS, with impact extending down the lower parts of the system (i.e. the Nyacyonga River) before entering the Nyabugogo River. As with all the other mined systems, extreme suspended sediments result in severe impacts to aquatic biota that would be expected to occur within the rivers under improved clarity conditions.

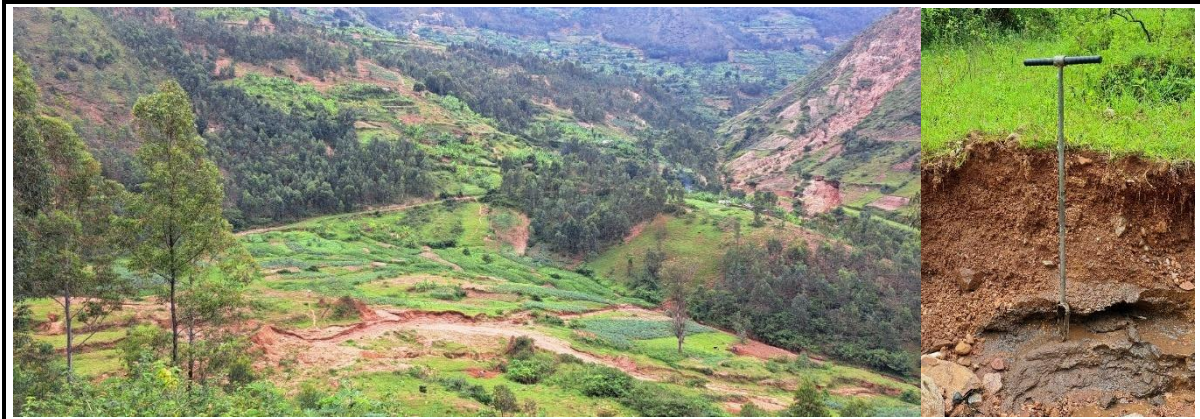
One of the headwaters of the Sanzari River. This area is heavily utilized for subsistence agricultural activities, along with being a source of water for the Rutongo Mine headquarters. Evidence of historical wetland habitat is present in the remaining vegetative communities e.g. *Leersia hexandra*, *Fimbristylis dichotoma*. Historical wetland habitat (extensive organic layer and soil indicators) buried under 0.5m of sediment.

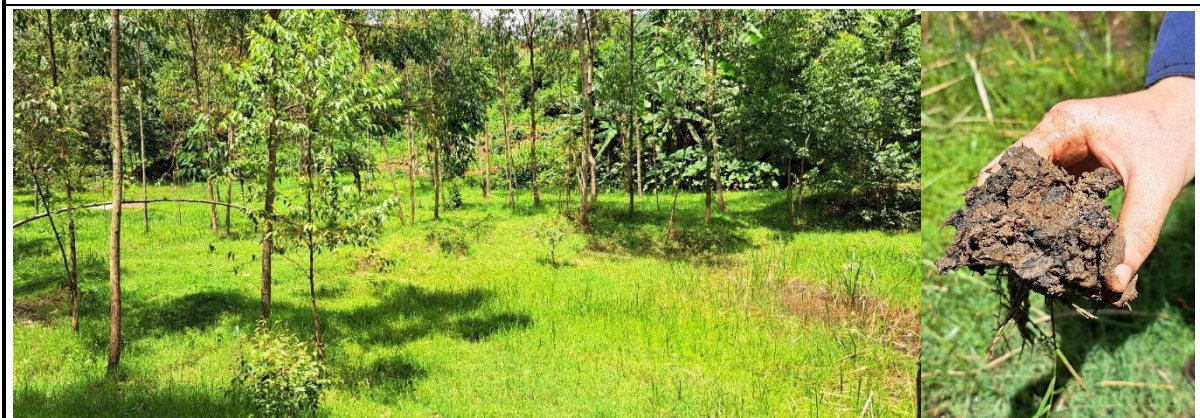
Pockets of wetland habitat adjacent to the Sanzari River just above the confluence with the Kivomo River. Signs of historical disturbance in this area were present which is likely associated with the harvesting of clay material for brick making. However, vegetative and soil indicators present. Current impacts include the *Eucalyptus* sp. within the wetland habitat.

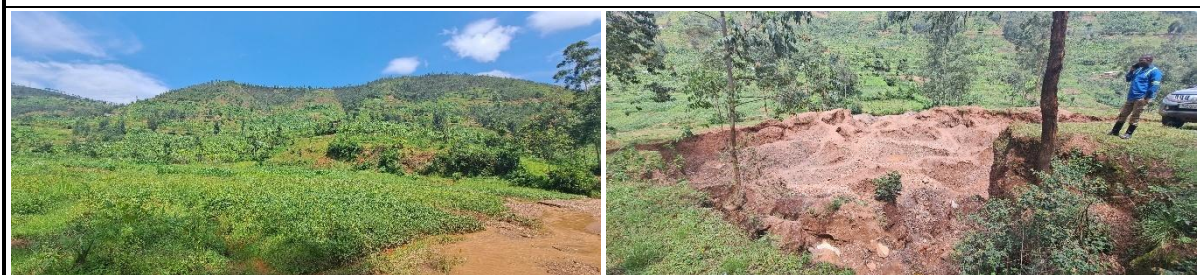
The valley-bottom wetland associated with the Upper Rusine River has been extensively cultivated with a variety of subsistence crops. Sedimentation of the channel and directly adjacent habitat is mostly associated with the illegal mining along the river.

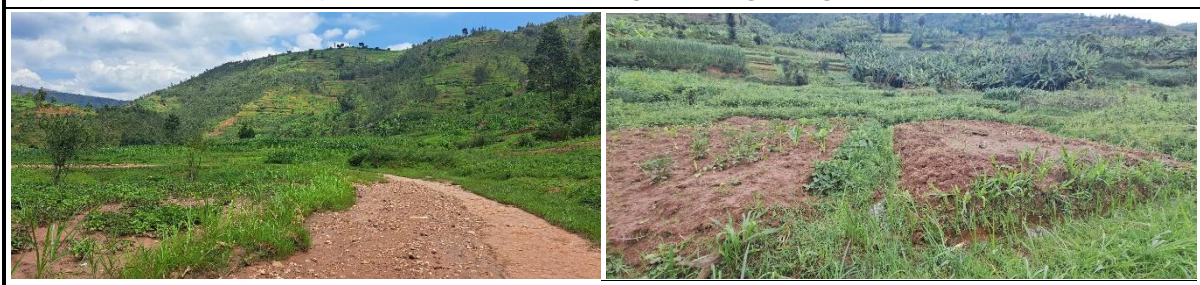
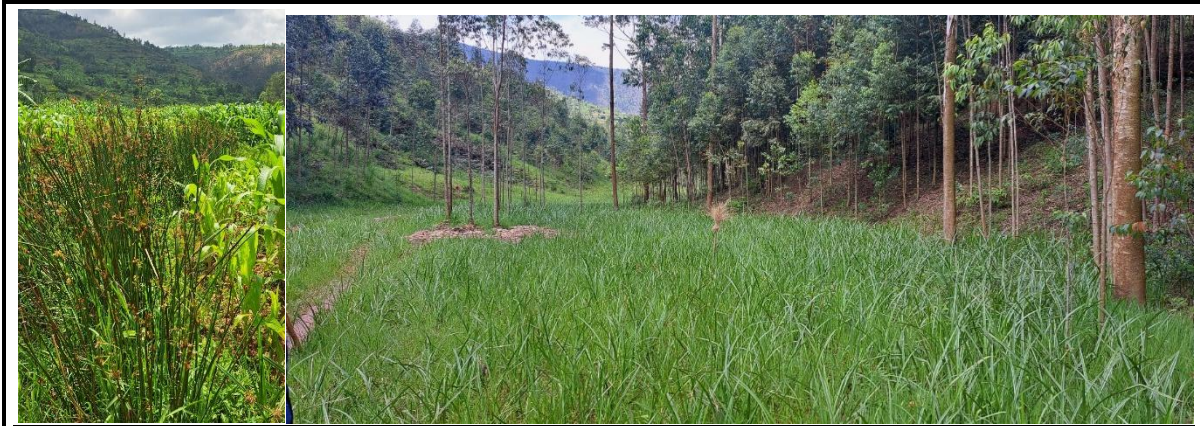
Extensive valley-bottom wetland systems downstream along the Rusine River (but upstream of the Nyiramududu tributary). Large portions of the systems have been extensively cultivated with limited wetland vegetation remaining – predominantly in the extensive drainage network. Portions of the valley-bottom has been subject to sedimentation in which portions of the cultivated areas are buried in +/-5cm of soil. The lower portion of the valley-bottom is uncultivated however, *Cyperus* sp. (local name Urukangaga) is maintained and harvested for mat making.

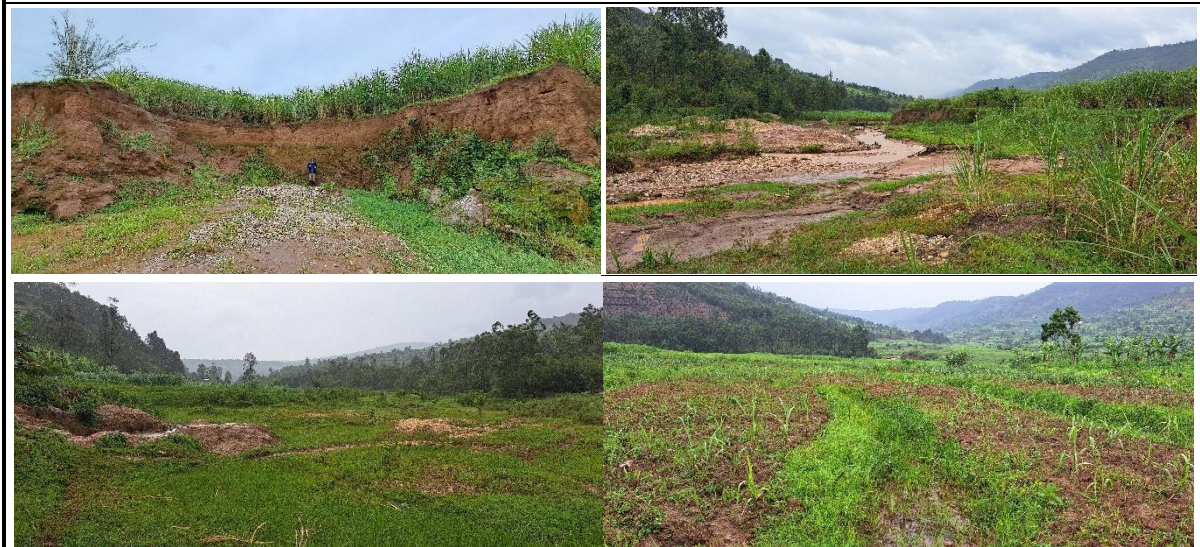
Rusine River upstream of the confluence with the Kilimbi Stream. Pockets of wetland habitat along the flood terraces adjacent to the Rusine River. Similar to other wetlands, these have been modified through the harvesting of clay material.

The large wetland, which was historically linked to the Rusine River and maintained through overbank topping and lateral seepage inputs is currently only maintained via lateral inputs due to incised nature of the River (+-7m below original ground level). Wetland has been extensively modified through agricultural production – commercial and subsistence.

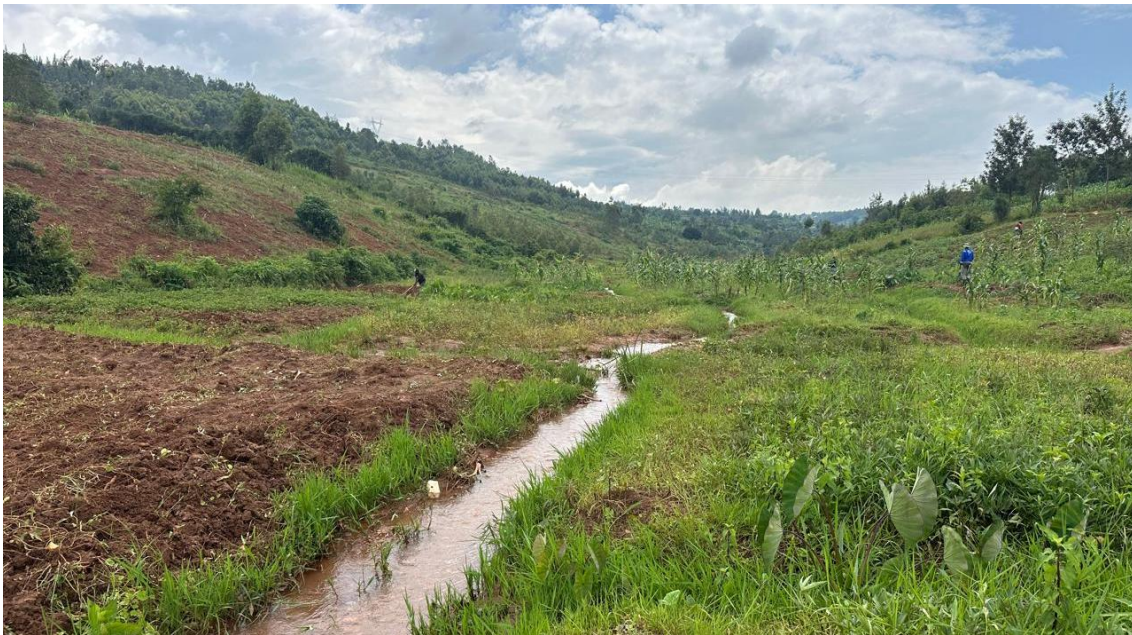
Upper portion of the Musha system closest to the mine. Characterised more by channelled valley bottom wetlands than river. Impacts include channel modification (straightening) and extensive drainage networks to support the subsistence agricultural activities.

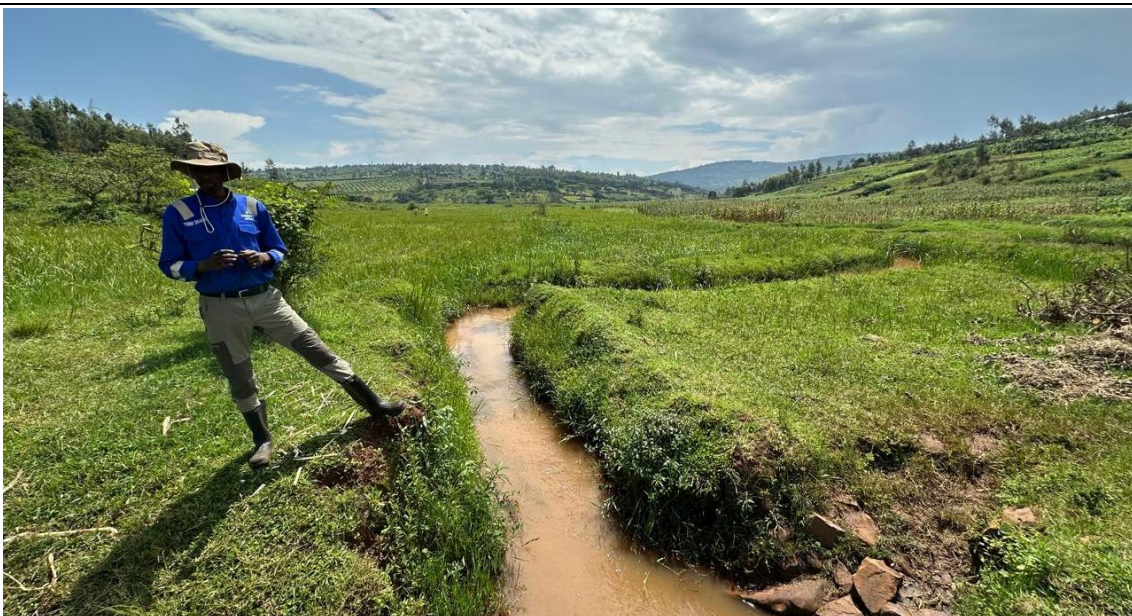
Withing the lower portion of the system, in which the impacts have remained relatively unchanged from the upper reaches other than that there are some intact portions of wetland habitat upstream which may contribute towards improving the integrity and functionality of the system.

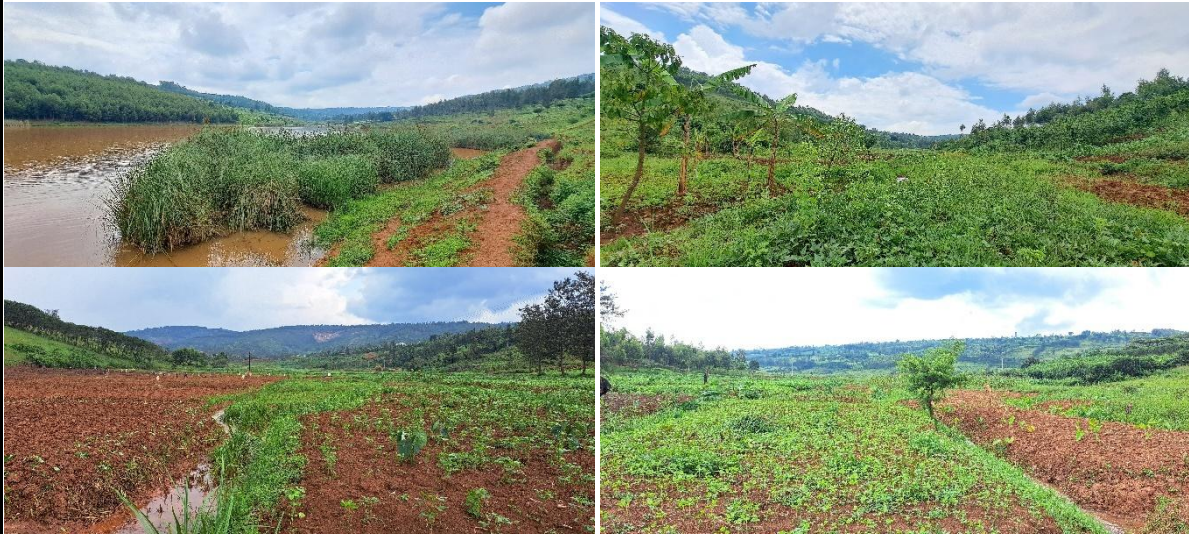
The wetland habitat has been substantially modified through the construction of the Bisinia Dam, and the extensive drainage network associated with the subsistence agricultural activities.

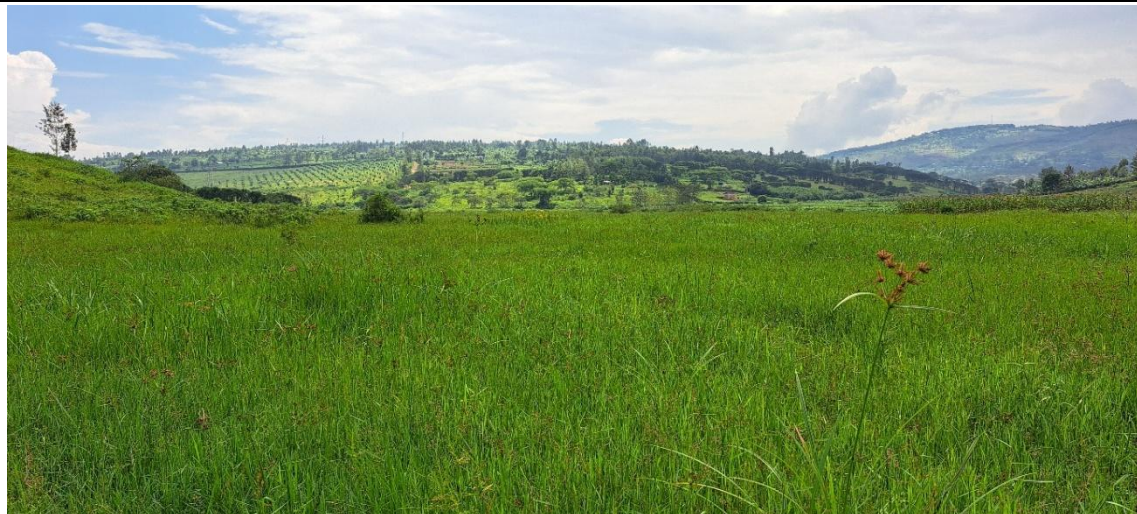
The lower portion of the Musha wetland (upstream of the backwaters of Lake Muhazi) is less impacted than upstream, as a large area remains uncultivated.

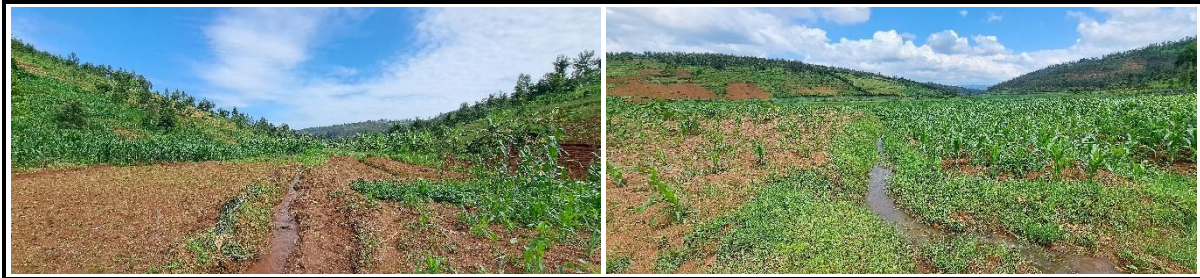
The wetland habitat associated with the Rwakiramba valley has been substantially modified through both subsistence and commercial (co-operative) agricultural activities. An extensive drainage existing throughout the length of the system to allow for the cultivation of crops.

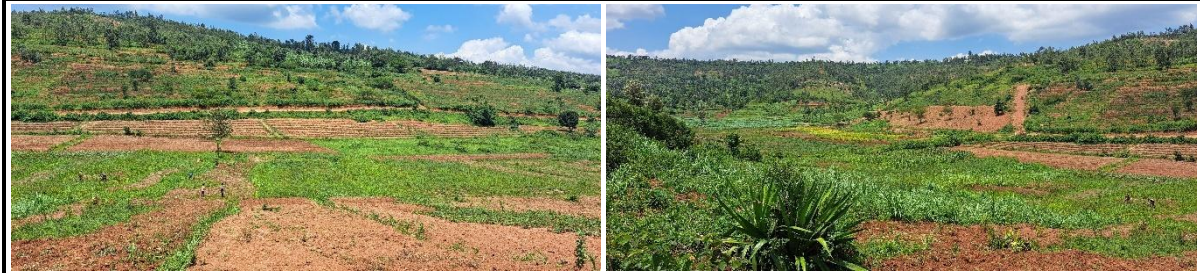
The wetland habitat associated with the Nyabigugu valley has been substantially modified through subsistence agricultural activities. Along with the others, this includes extensive drainage networks and loss of wetland vegetation, among others.

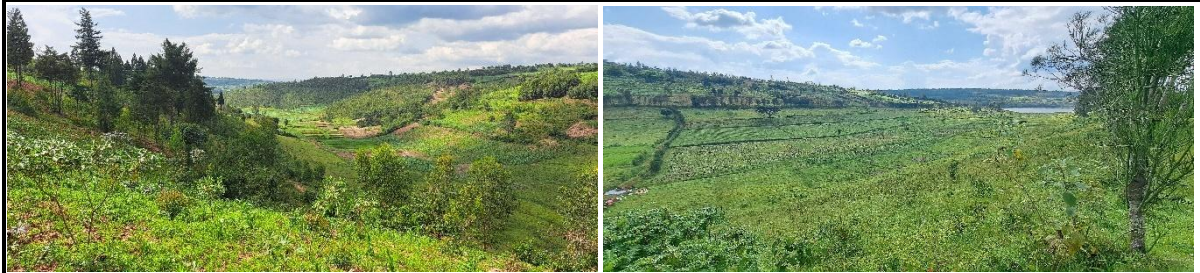
The Rubonobono and Rukombe valleys have the same characteristics to the Nyabigugu valley system and have been significantly modified through subsistence agricultural activities.

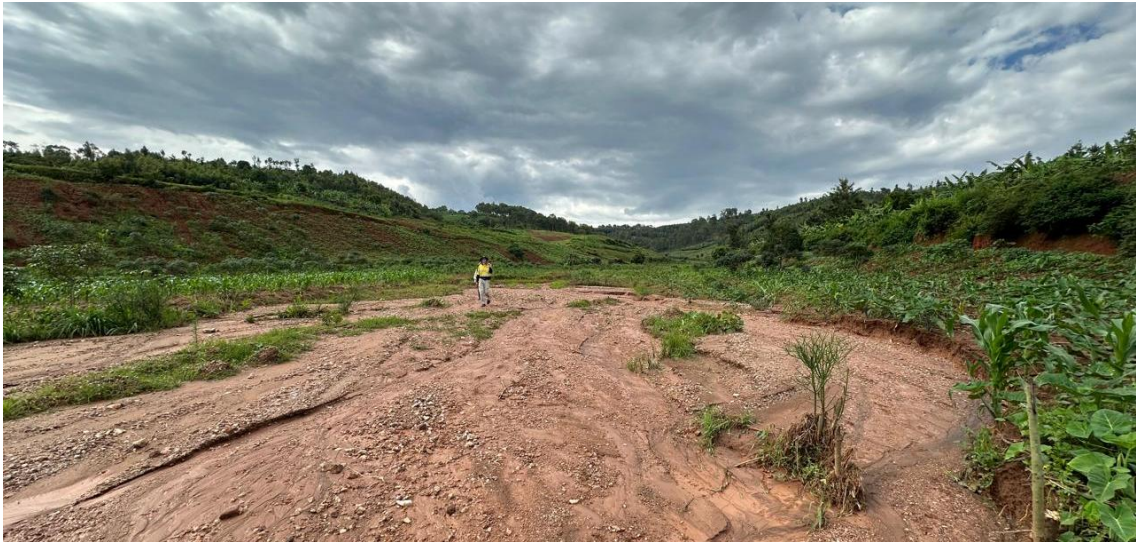
Headcut erosion within the upper reaches of the system, followed by a large sediment deposit within the gully, filling the gully. From here there is no defined channel.

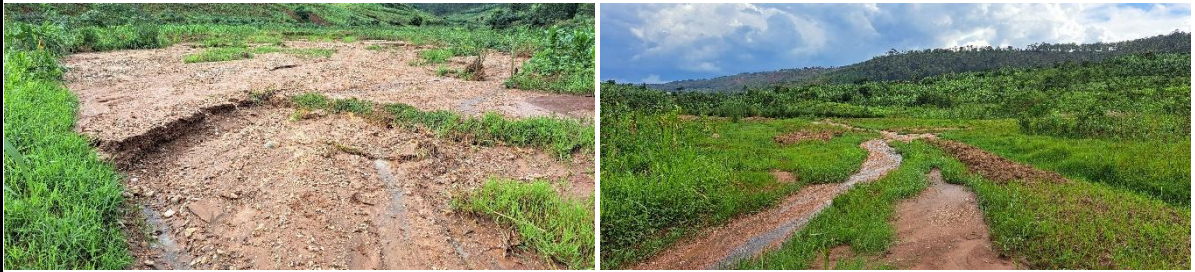
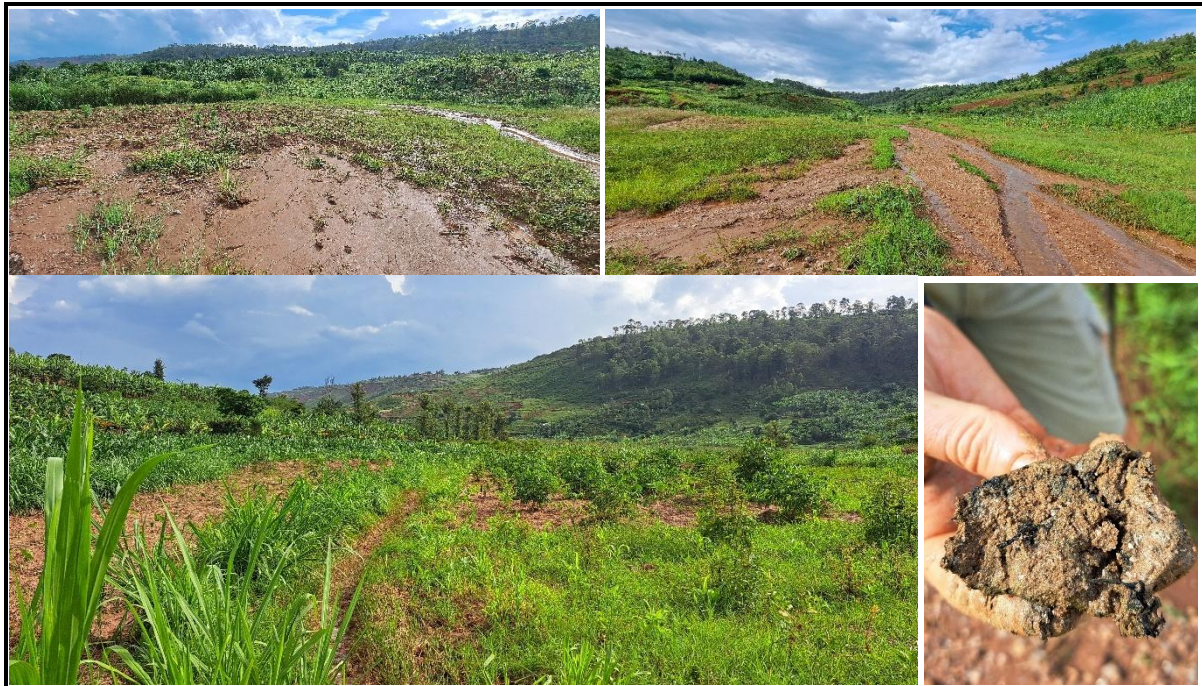
The valley-bottom wetland is sustained by lateral inputs and seepage within the channel. The wetland has been significantly modified through subsistence agricultural practices, including crops, drainage networks etc. Sediment inputs into the system are predominantly from the upstream catchment resulting in the burying of crops in fine sediments. Soil indicators are present within the soil but limited vegetative indicators due to the modifications.

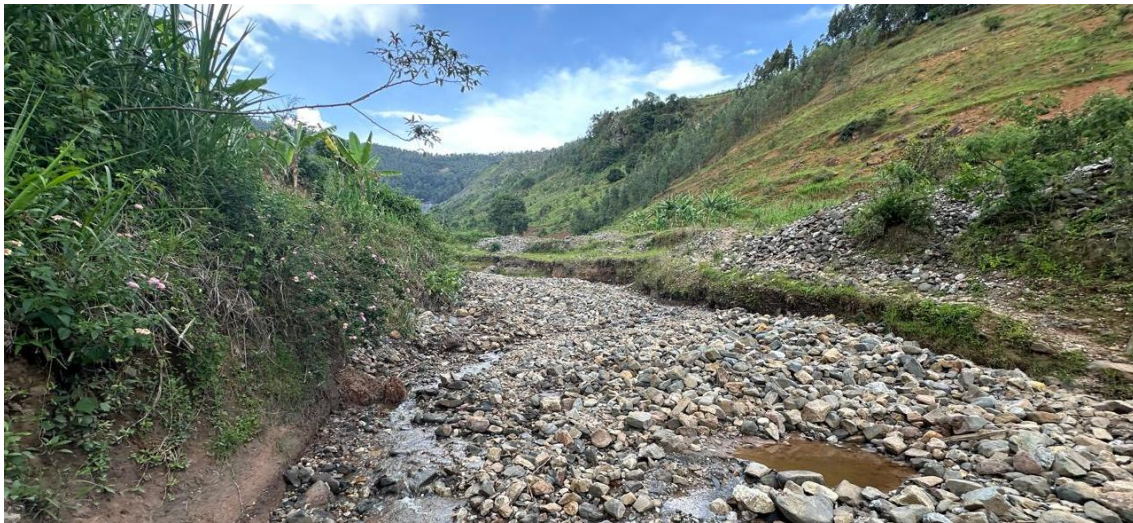
Evidence of deposits of rock within the channel from the upstream mining activities i.e. lots of mining aggregate/rocks but limited fines/sand. The change in sediment loads and flows have contributed to the incision of the channel. Extensive colonisation of alien invasive vegetation along the channel banks.

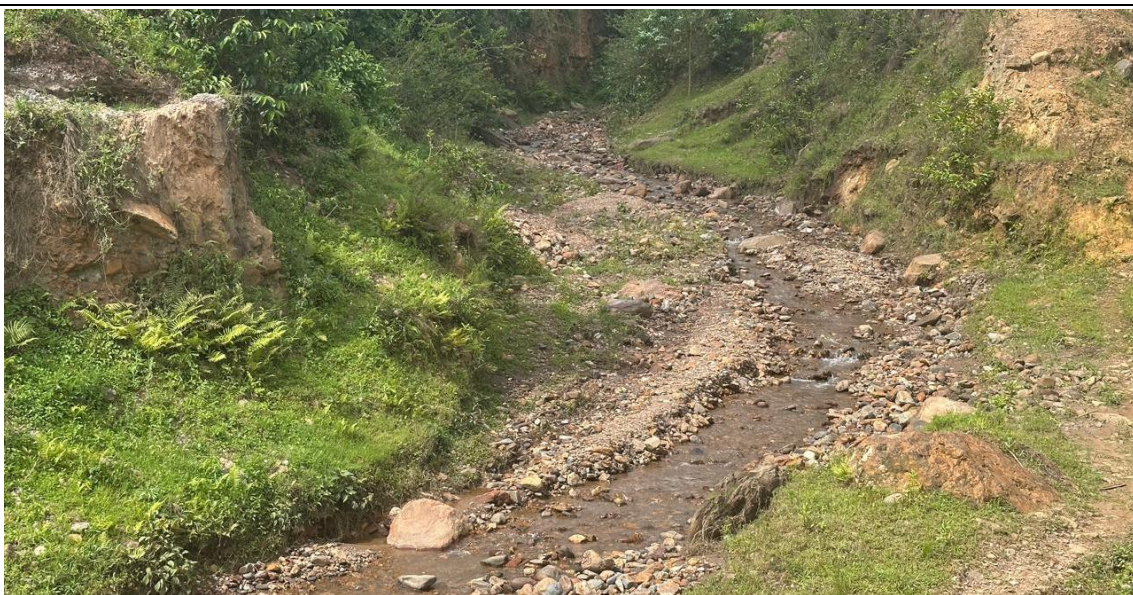
Within the mid-reach of the Nyakabingo River, where more fines/sand/small aggregate have been deposited. The width and depth of channel incision is variable between the upper and mid-reaches of the system. The overall PES of the system has been influenced by the constant movement and deposition of stone and sediments, as well as bank erosion and presence of exotic vegetation.

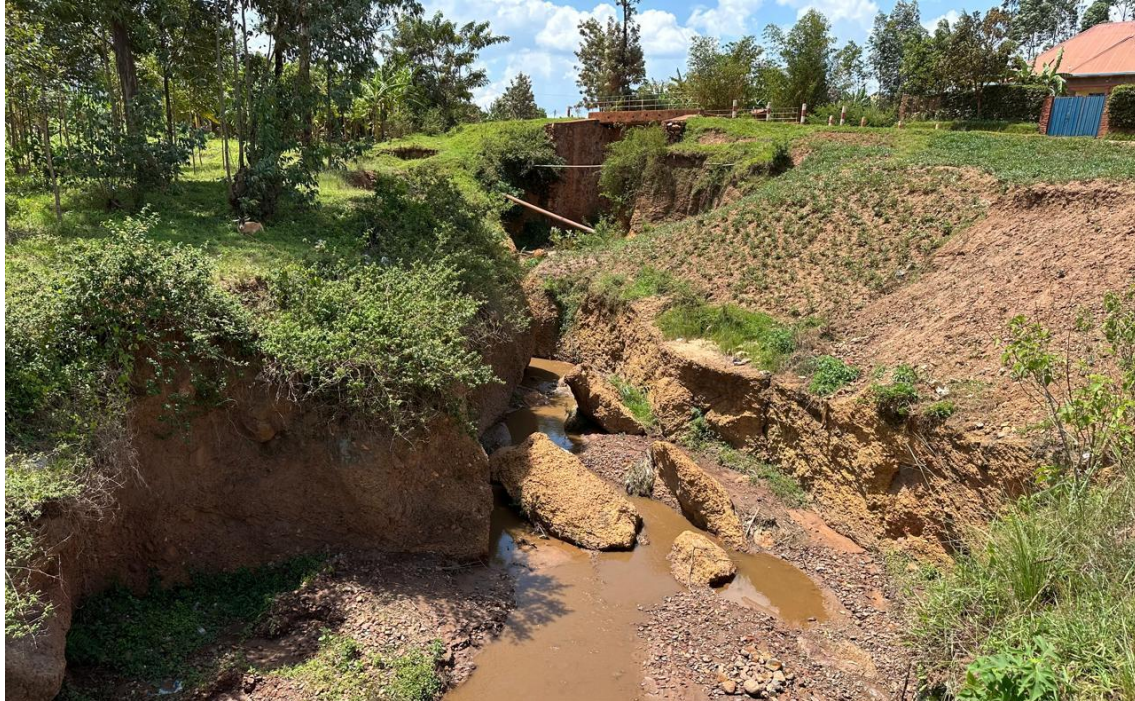
In the lower reaches of the Nyakabingo river near the town of Amajyaruguru town, the impacts on the system are largely associated with upstream mining activities with additional impacts from the surrounding urban landscape, e.g. incised channel, litter, infrastructure crossings such as bridges and pipelines.

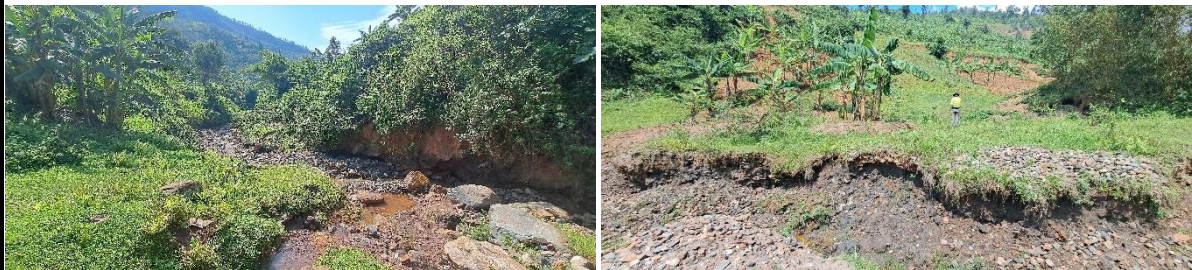
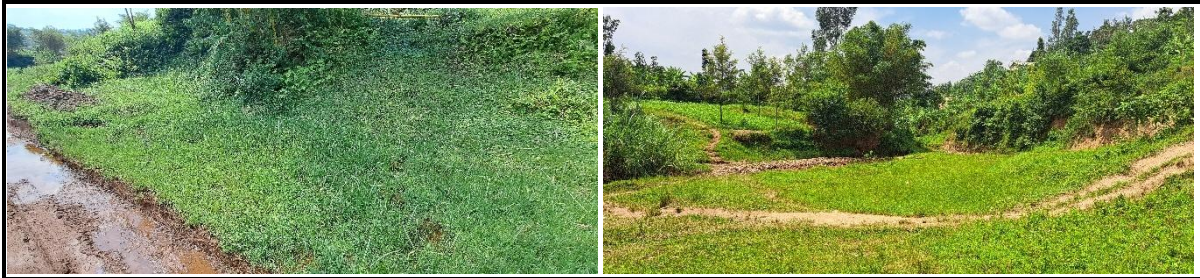
The Nyakabingo valley has very limited wetland habitat along the lengths of the valley. This is linked to the fact that the valley is very narrow with limited opportunity for the formation of wetland. There are a series of wetland habitat pockets along the fringes of the channel. Some of these pockets have become desiccated and/or smothered in sediments, whilst others are increasingly becoming more cultivated.

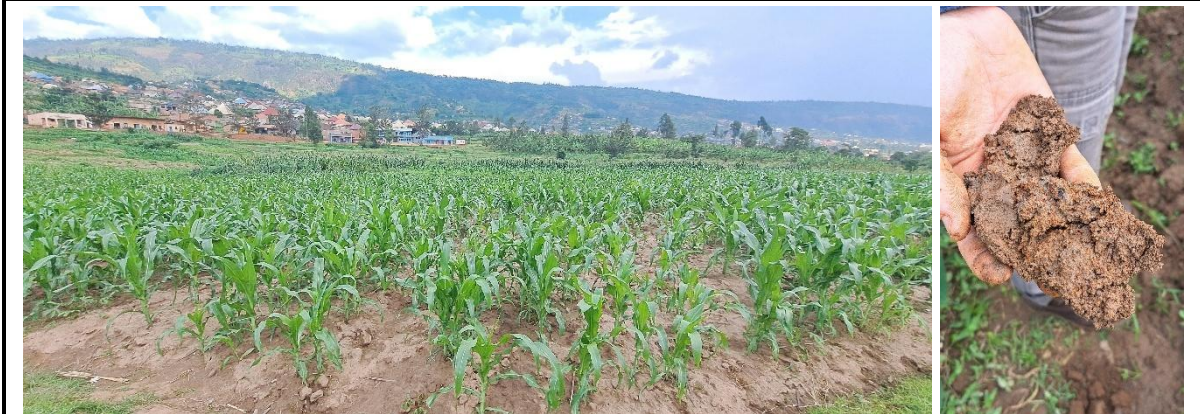
Possible origin of the wetland is a levy along the Nyakabingo River which is preventing the flows from the surrounding town from decanting into the river, and therefore, is collecting it in a small basin-type feature in the lower reaches of the town. This area has been substantially cultivated.
