SOURCE PATHWAY RECEPTOR ANALYSIS

TRINTY METALS

DRAFT V.02

GT1377/022026/02

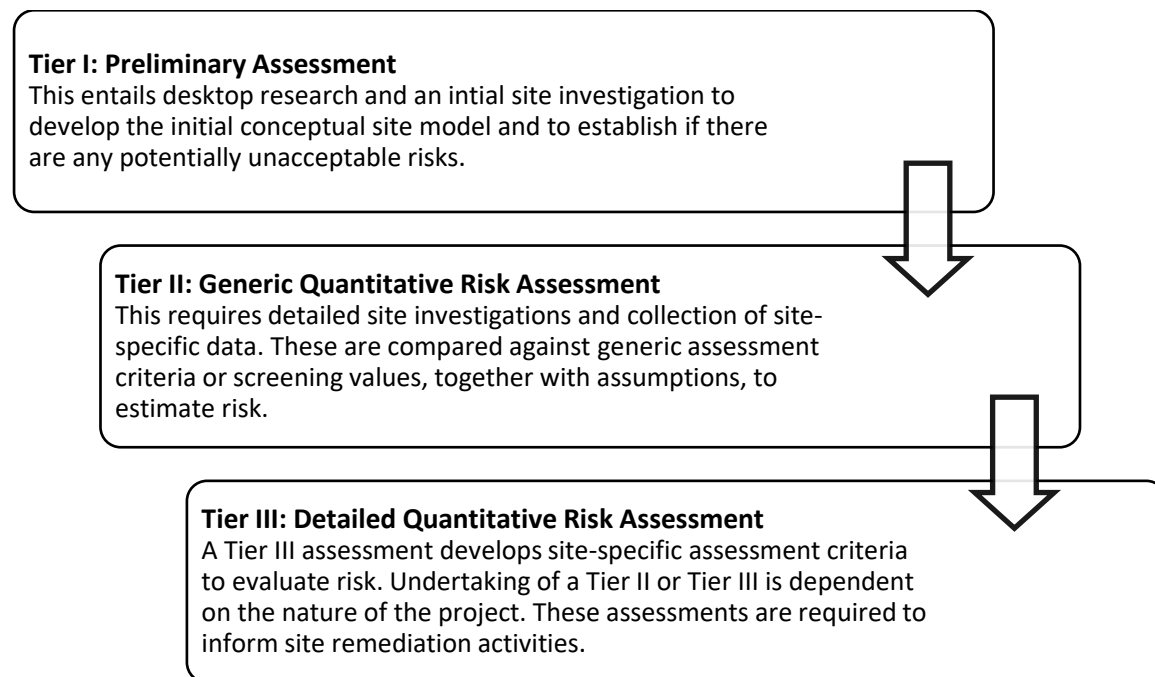
Figure 2-1 General phases of assessment and management of risk related to contaminated land or groundwater (Adapted from DEA, 2010)

In general, the assessment process encompasses three tiers of assessment, as summarised in **Figure 2-1** below.

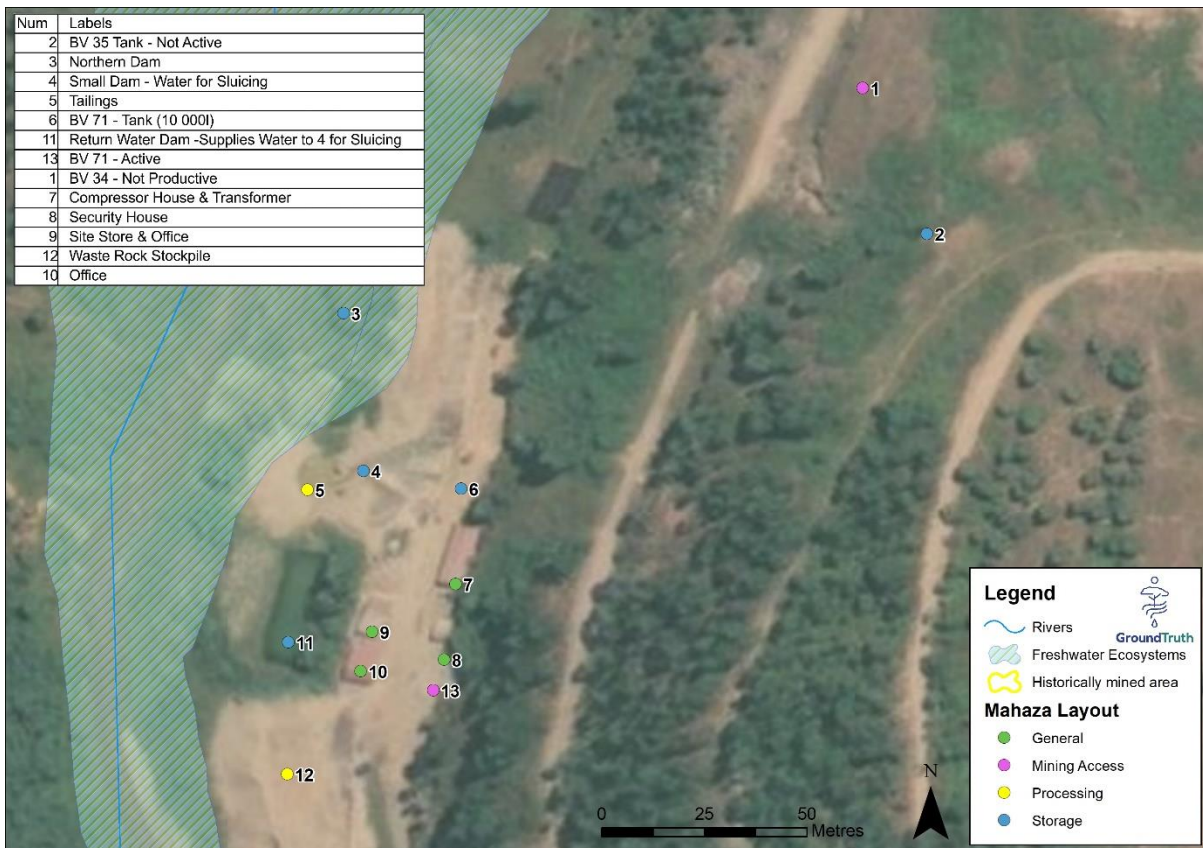
Figure 4-6 Layout of Mahaza (satellite mine site)
